Technical product information

Topic	Coolant leaking from the mechanical coolant pump - Low coolant level warning - Engine overheating - DTC's evident
Market area	Russische Föderation (5RU),Australia E04 Bentley rest Asia and Australia (6E04),China 796 VW Import Comp. Ltd (Vico), Beijing (6796),Germany E02 Bentley rest Europe (6E02),Japan E03 Bentley Japan (6E03),Korea, (South) E08 Bentley South Korea (6E08),United Arab Emirates E06 Bentley Middle East and Africa (6E06),United Kingdom E01 Bentley UK (6E01),United States E05 Bentley USA and rest America (6E05)
Brand	Bentley
Transaction No.	2065919/5
Level	EH
Status	Approval
Release date

W12 Bentayga - New Continental GT/GTC - New Flying Spur

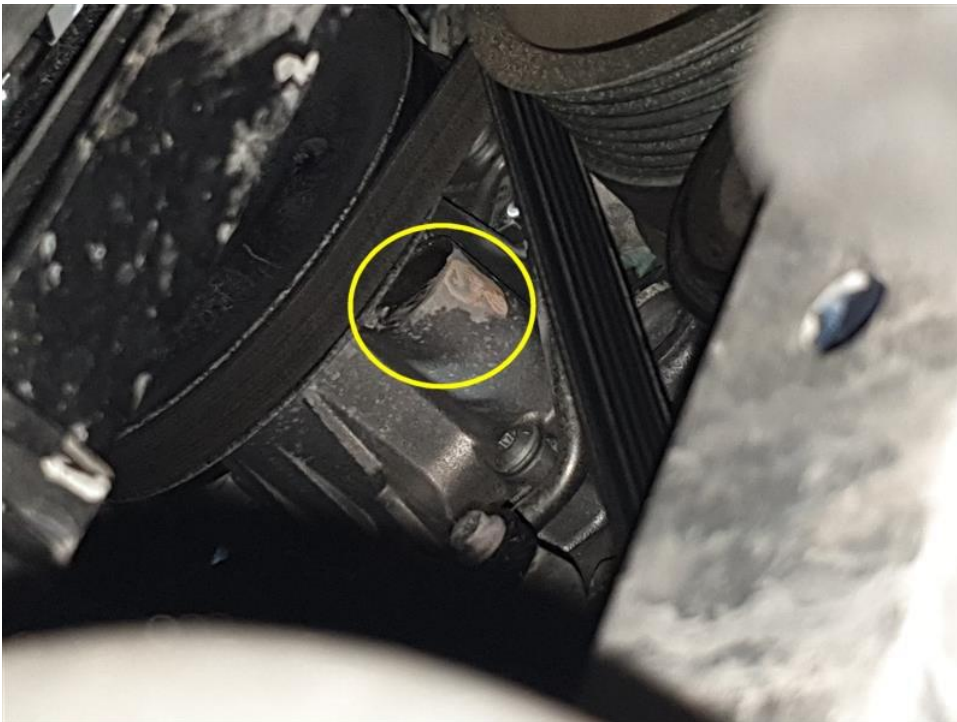
Figure 2

Refer to the video located within the Bentley Hub reference TPI 2065919/- this video shows an example of a coolant pump with no leak although there is a small coolant witness mark evident (Figure 2) in this scenario the coolant witness mark should be cleaned off (using a suitable cleaning agent) to the condition shown in Figure 3

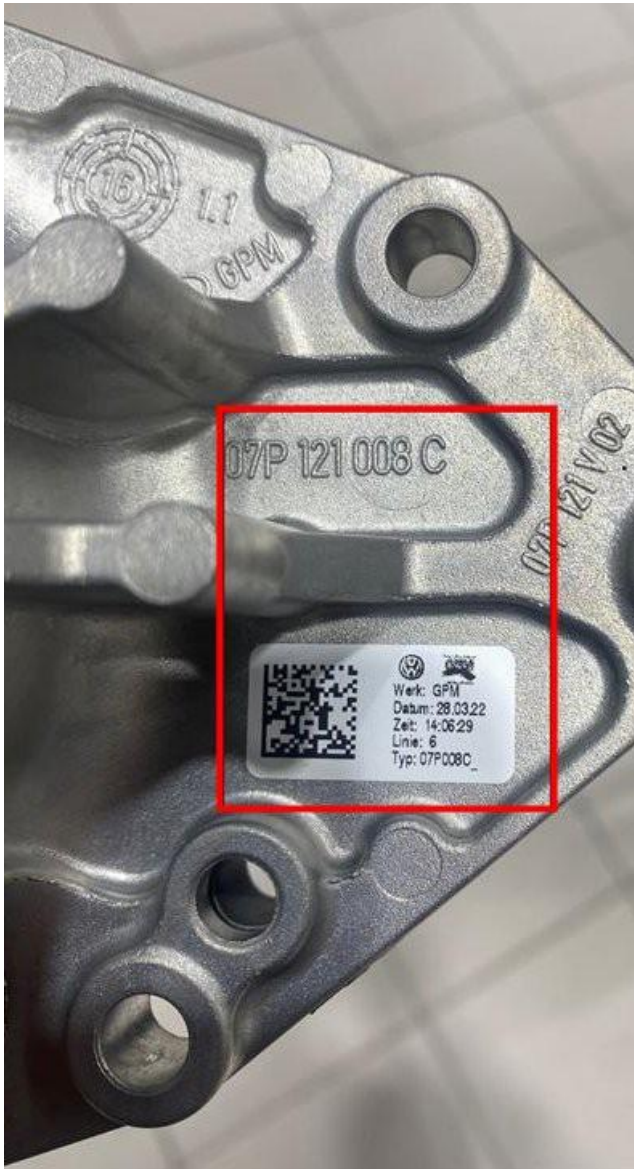
NOTE: The photo shown in Figure 4 is a C level coolant pump (shown removed from the vehicle for photographic purposes) a borescope may have to be used for photos of the coolant pump when fitted

- Once permission has been given via the technical DISS query, replace the following
- Mechanical coolant pump - Rep.Gr 19
- Solenoid for coolant circuit N492 assembly - Rep.Gr 19
