Technical product information

Topic	Overheat condition-DTC logged for air in the system or DTC P218100-Cooling System Performance with symptom code 8113
Market area	Bentley; worldwide (2WBE)
Brand	Bentley
Transaction No.	2051893/4
Level	EH
Status	Approval
Release date

Overheat condition-DTC logged for air in the system or DTCP218100-Cooling System Performance with symptom code 8113

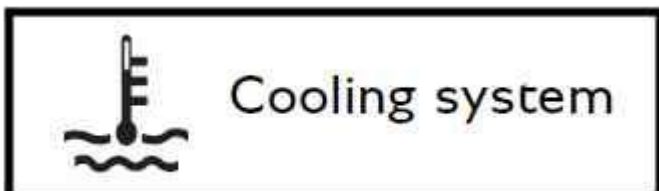
- Warning light within the Drivers Information Panel (DIP)

- Coolant loss
- Diagnostic trouble codes (DTC's) logged within the Engine control module/s relating to "Air in the coolant system"
- Engine overheating issues and/or DTCP218100: Cooling System Performance symptom code 8113 is evident

- 1) Fully drain the cooling system - Refer to Elsa Pro Rep.Gr 19 Cooling system - To drain and fill
- 2) Replace the Thermostat housing (includes thermostat) - Refer to Elsa Pro Rep.Gr 19 Cooling system - Thermostat - To replace
