PSS 93 Electrical Malfunction Message Displayed on Start up, DTCs P060600 and P0A1B00 Stored in Electric drive 2

93 22 93 2068370/2 December 16, 2022. Supersedes Technical Service Bulletin Group 93 number 22-84 dated November 7, 2022, for reasons listed below.

Model(s)	Year	VIN Range	Vehicle-Specific Equipment
Q4 e-tron quattro, and Q4 Sportback e-tron quattro	2022	All	Not Applicable
	2023	000001 - 000056

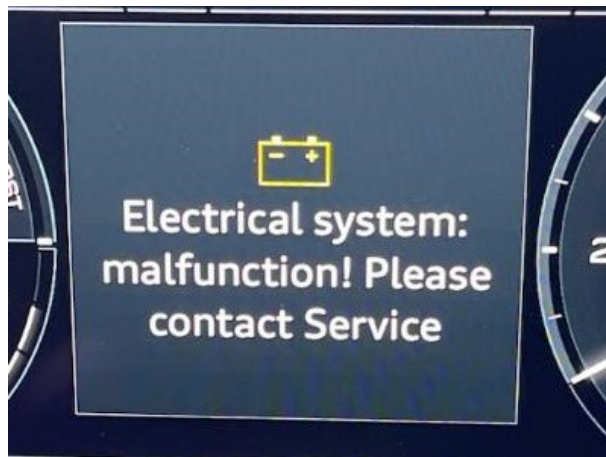
- Intermittently at start-up driver receives a malfunction message in the instrument cluster “Electrical system malfunction! Please contact Service” (Figure 1).
- After a key cycle the vehicle operates normally.

Figure 1. A malfunction message is shown in the instrument cluster.

Software communication timing error on start-up.

- The warning is displayed on vehicle start-up.
- After an ignition cycle the vehicle operates normally.
- Clear the DTCs with the scan tool and confirm the vehicle drives normally on a test drive.

If the DTCs can be cleared and the vehicle drives normally the vehicle can be released to the customer.

Do not replace any parts as it will not fix the concern.

Explain to the customer if the concern happens again they should turn the ignition off, wait a couple of seconds, and then turn the ignition back on. The vehicle will then operate normally.
