SERVICE BULLETIN

APPLICABILITY: 23MY Outback/Legacy Models

NUMBER: 15-305-22R

SUBJECT: Reprogramming File Availability for Optimization of Gen 4 Denso CP1.5 Infotainment Systems

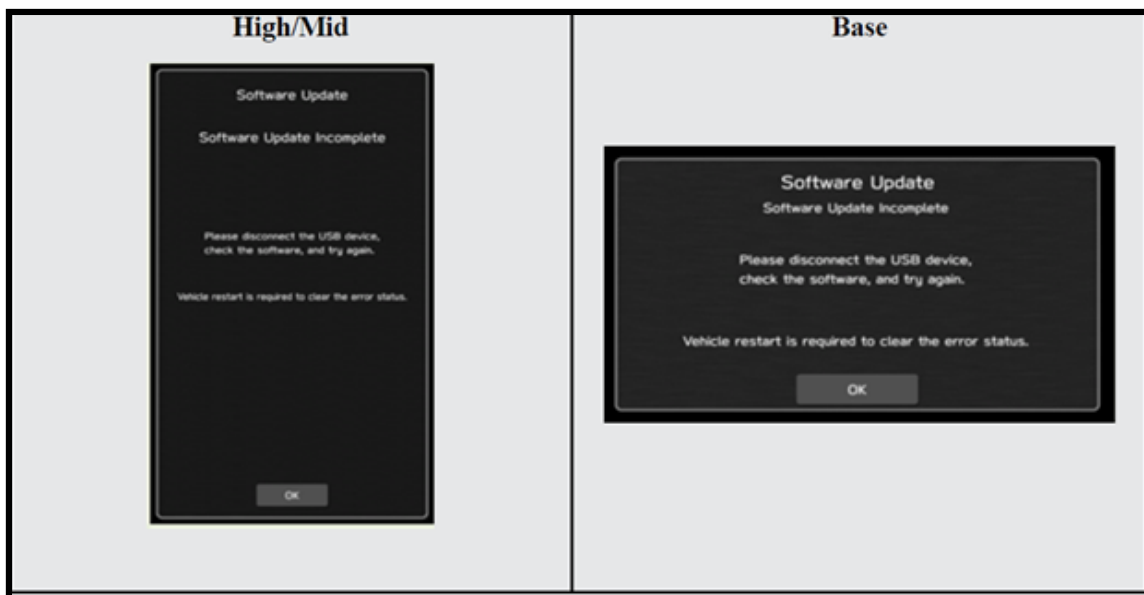
If you get the message **Software Update Incomplete** as shown below, please don't replace the hardware but retry updating the software according to the instructions in "**Appendix B**" on pg. 17.

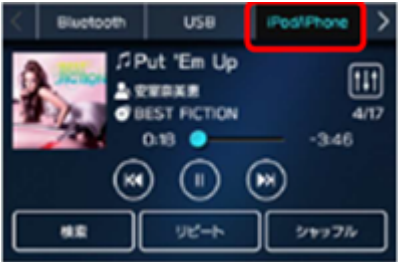
Number	Symptoms to be Improved:
1	<p>iPod/iPhone tab in Media screen cannot be selected, when connected by USB.</p> <p>The symptom occurs when the iPhone is connected to CP1.5 via Bluetooth in parallel to USB connection by error. (It is supposed to be connected either via Bluetooth or by USB.)</p>

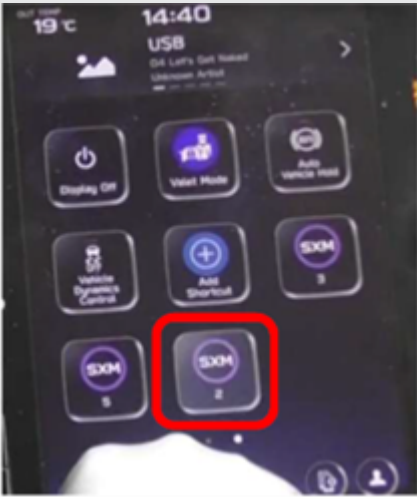
Number	Symptoms to be Improved:
5	Cannot pair Bluetooth device, when Bluetooth device has long name including symbols.
6	<p>SXM station shortcut created by the customer does not work when the SXM has not been used as audio source after the Ignition Switch was turned on in the ignition cycle.</p>
