Technical product information

Topic	Rear lamp gap/profile and alignment
Market area	Russische Föderation (5RU),Australia E04 Bentley rest Asia and Australia (6E04),China 796 VW Import Comp. Ltd (Vico), Beijing (6796),Germany E02 Bentley rest Europe (6E02),Japan E03 Bentley Japan (6E03),Korea, (South) E08 Bentley South Korea (6E08),United Arab Emirates E06 Bentley Middle East and Africa (6E06),United Kingdom E01 Bentley UK (6E01),United States E05 Bentley USA and rest America (6E05)
Brand	Bentley
Transaction No.	2068609/1
Level	EH
Status	Approval
Release date

New Continental GT/C and New Flying Spur

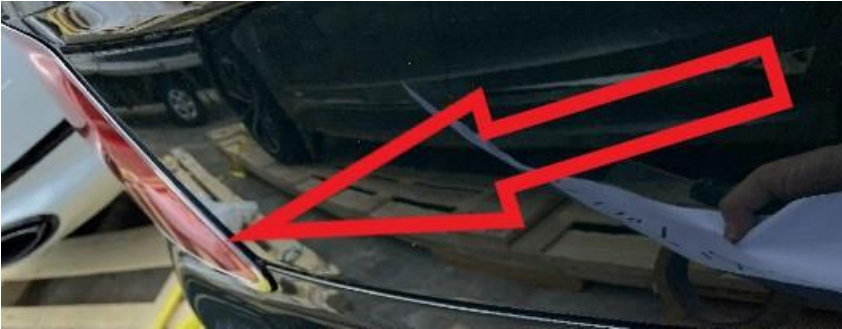
Figure 1

Rear lamp gap/profile appears to be out of specification (Figure 1)

In the event the gap/profile is not to specification (as per the applicable Rep.Gr) the operative must continue as follows:

- Take a clear video/photograph of the gap/profile issue(s) ensuring the actual measurements of the out of specification gap/profile is clearly shown
- Referring to the applicable Rep.Gr - Conduct the required adjustment of the rear lamp ensuring that once adjusted the required tolerances have been achieved

- Take a clear video/photograph of the gap/profile
- Raise a non-technical DISS query stating the following:
- The gap/profile were not to specification
- Prior and post adjustment measurements (video/photographs) have been attached to the non-technical DISS query
