## Technical product information

<b>Topic</b>	Rear lamp gap/profile and alignment
<b>Market area</b>	Russische Föderation (5RU),Australia E04 Bentley rest Asia and Australia (6E04),China 796 VW Import Comp. Ltd (Vico), Beijing (6796),Germany E02 Bentley rest Europe (6E02),Japan E03 Bentley Japan (6E03),Korea, (South) E08 Bentley South Korea (6E08),United Arab Emirates E06 Bentley Middle East and Africa (6E06),United Kingdom E01 Bentley UK (6E01),United States E05 Bentley USA and rest America (6E05)
<b>Brand</b>	Bentley
<b>Transaction No.</b>	2068609/2
<b>Level</b>	EH
<b>Status</b>	Approval
<b>Release date</b>

### New Continental GT/C and New Flying Spur

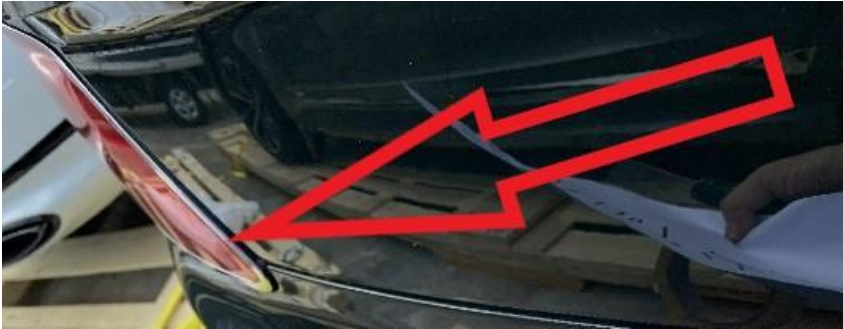
Figure 1

Rear lamp gap/profile appears to be out of specification (Figure 1)

**IMPORTANT:** The operative **MUST** refer to the onward instructions to confirm if the rear lamp gap/profile is to specification before raising a DISS query

Due to the design and fitment of the rear lights in relation to the surrounding components the operative must refer to Rep.Gr 94 (New Continental GT/C) to confirm if the gap/profile of the rear lamps is to specification before conducting any adjustments or before raising a technical DISS query

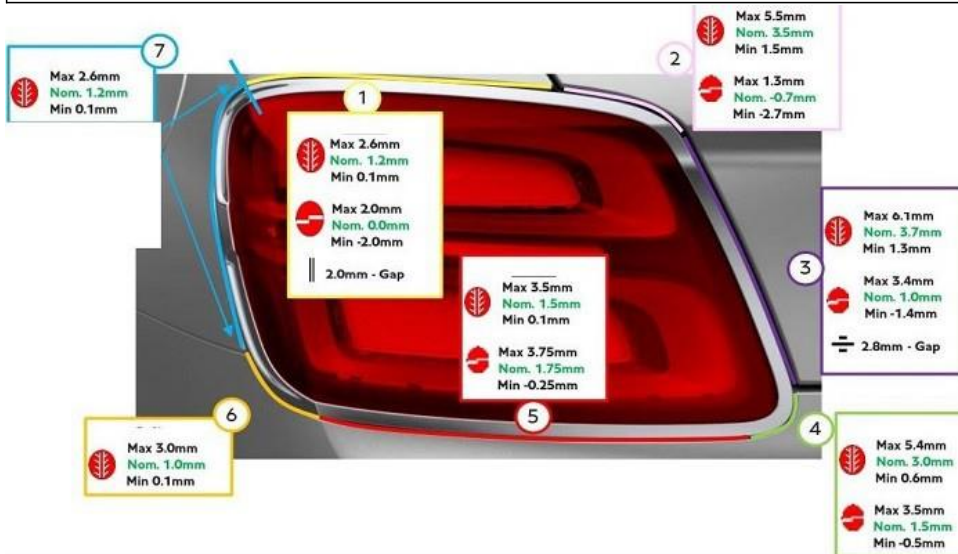
New Flying Spur - Refer to Figure 2

In the event the gap/profile is not to specification as per Rep.Gr 94 - Rear lamps - To remove and fit or Figure 2 for New Flying Spur

In the event the gap/profile is not to specification (as per Rep.Gr 94 or Figure 2 for New Flying Spur) the operative must continue as follows:

- Take a clear video/photograph of the gap/profile issue(s) ensuring the actual measurements of the out of specification gap/profile is clearly shown
- Conduct the required adjustment of the rear lamp ensuring that once adjusted the required tolerances have been achieved

- Take a clear video/photograph of the gap/profile
- Raise a non-technical DISS query stating the following:
- The gap/profile were not to specification
- Prior and post adjustment measurements (video/photographs) have been attached to the non-technical DISS query
