Field campaign

Topic	Rear heated armrest functionality - Software update (SC22/36)
Market area	Australia E04 Bentley rest Asia and Australia (6E04),China 796 VW Import Comp. Ltd (Vico), Beijing (6796),Germany E02 Bentley rest Europe (6E02),United Kingdom E01 Bentley UK (6E01),United States E05 Bentley USA and rest America (6E05)
Brand	Bentley
Transaction No.	2068670/1
Campaign number	EC61
Note	
Type	
US code

Bentayga EWB

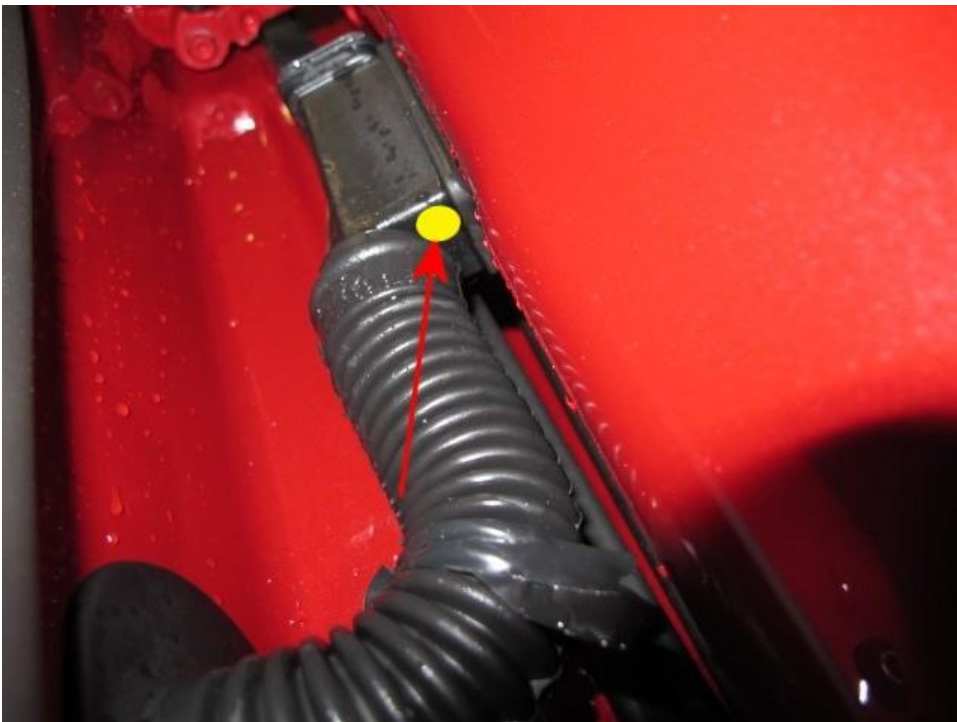
Figure 3

Yellow paint completion mark on the underside of the left hand rear door electrical connection confirms completion (Figure 3)

6. Apply a yellow paint completion mark on the underside of the left hand rear door electrical connection (Figure 3)
