# UPDATE PRIOR TO SALE NOTICE

Global Service Action  
Number: H426 UPS8822-3

<b>Subject:</b>  <h2>Camshaft Carrier Drill Hole</h2>	Publication No.: H426 UPS8822-3
	Model: F-PACE (X761)
	Model Year: 2023 - 2024
	Date of Issue: 09 December 2022
	Expiry Date: 09 December 2023

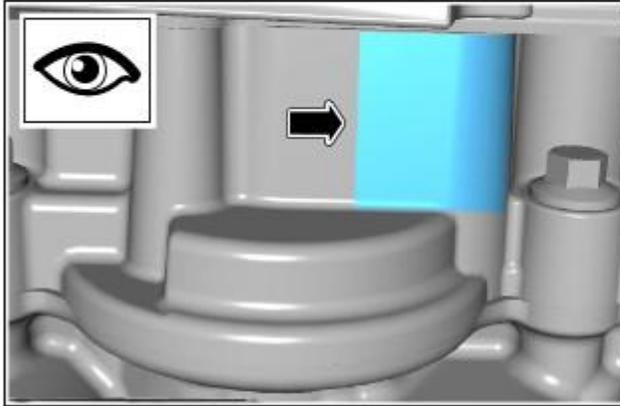
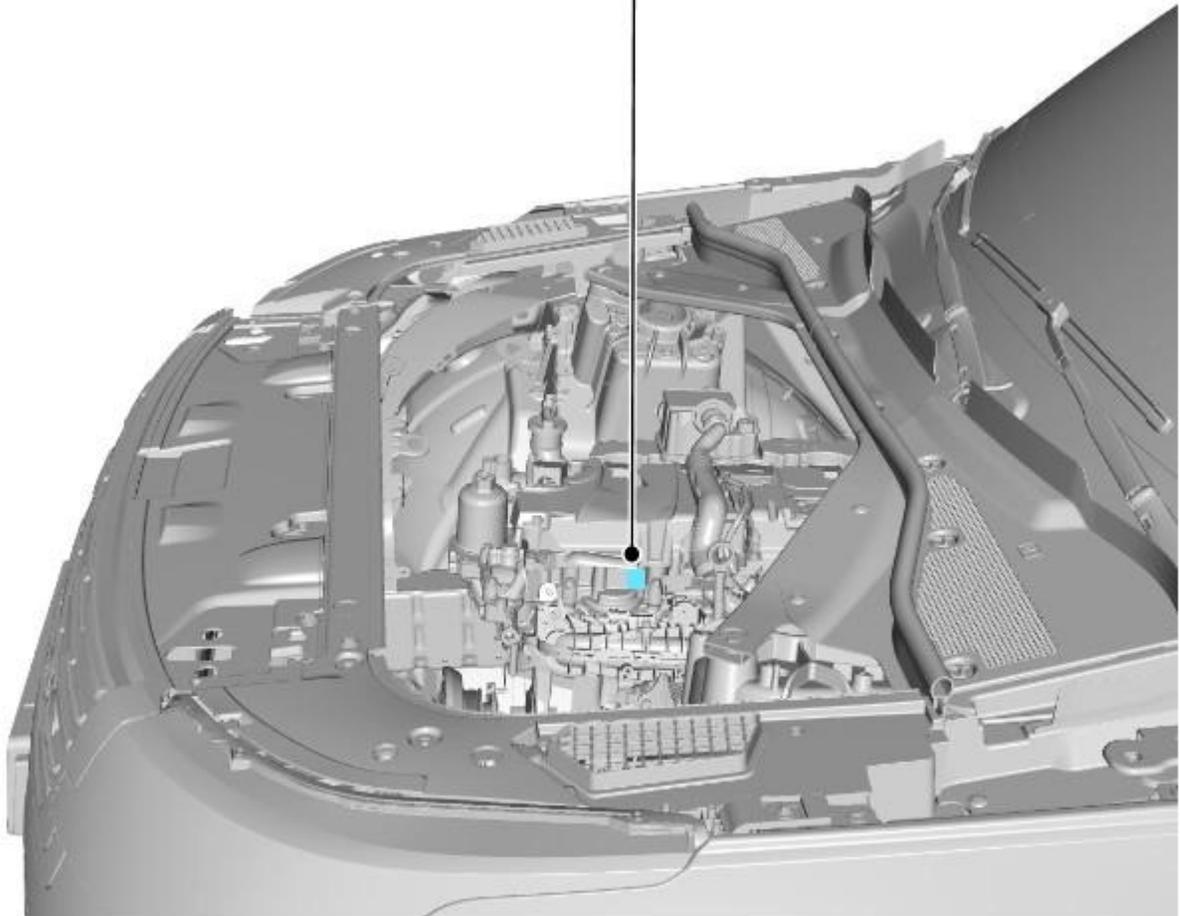
E323282

2. Locate the highlighted area of the camshaft carrier shown in the illustration.

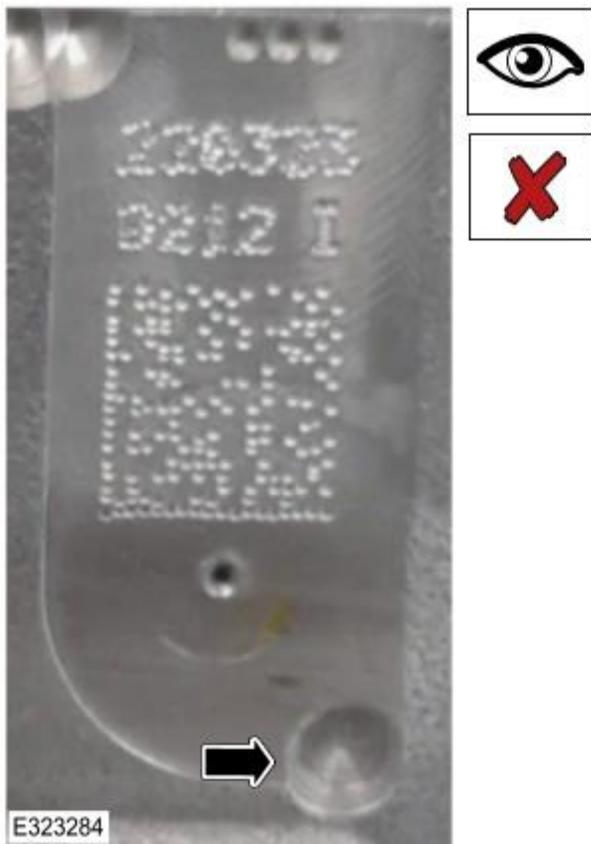
5. The failure condition shown highlights 1 drilled tooling mark in the lower right side of the tooling stamp.

If the 1 drilled tooling mark in the lower right side of the tooling stamp is present, then the vehicle has failed the inspection.

**Vehicles which failed the inspection:** Contact [jlrcamp@jaguarlandrover.com](mailto:jlrcamp@jaguarlandrover.com) and supply the full 17-digit [VIN](#) of the vehicle, **continue to quarantine the vehicle and wait for further instructions.**

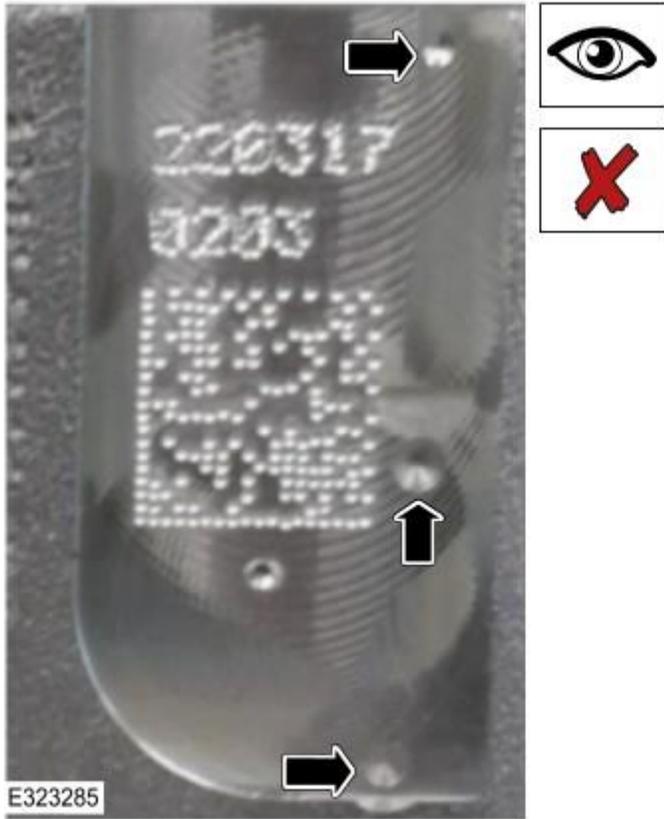
- 6. The failure condition shown highlights 3 drilled tooling marks in the upper, middle and lower right side of the tooling stamp.

If the 3 drilled tooling marks in the upper, middle and lower right side of the tooling stamp are **ALL** present, then the vehicle has failed the inspection.

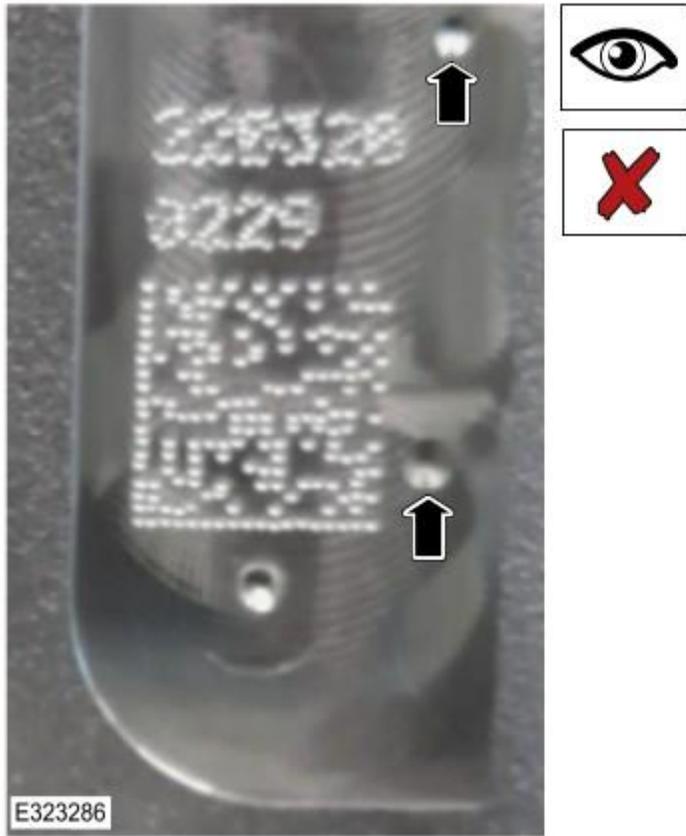
- 7. The failure condition shown highlights 2 drilled tooling marks in the upper and middle right side of the tooling stamp.

If the 2 drilled tooling marks in the upper and middle right side of the tooling stamp are **BOTH** present, then the vehicle has failed the inspection.
