UPDATE PRIOR TO SALE NOTICE

Global Service Action
Number: H426 UPS8822-4

Subject:	Publication No.: H426 UPS8822-4
Camshaft Carrier Drill Hole	Model: F-PACE (X761)
	Model Year: 2023 - 2024
	Date of Issue: 15 December 2022
	Expiry Date: 09 December 2023

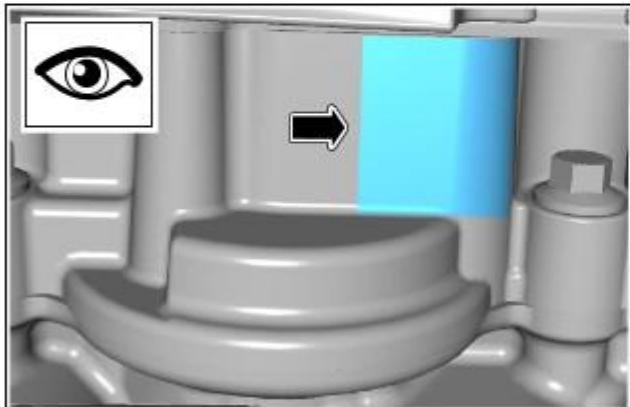
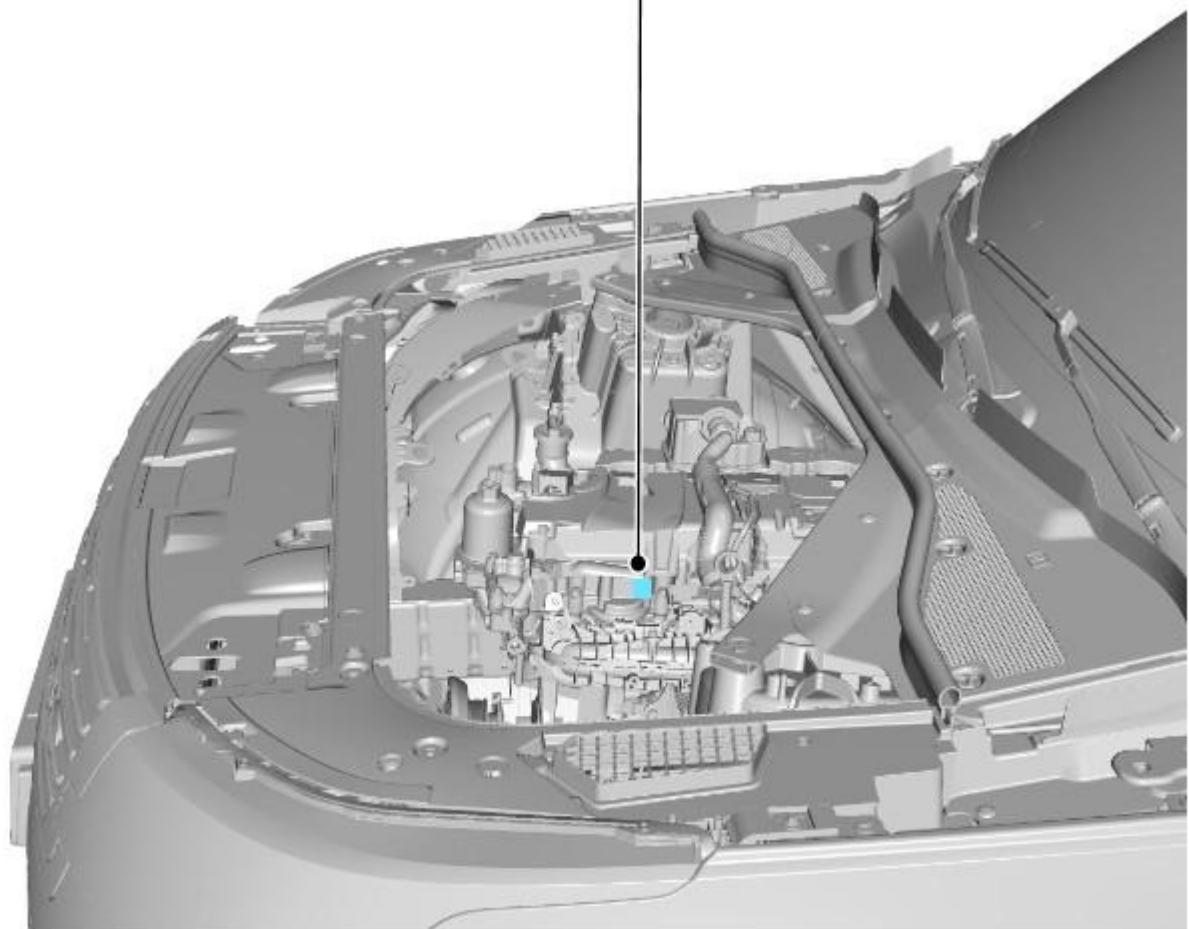
E323282

2. Locate the highlighted area of the camshaft carrier shown in the illustration.

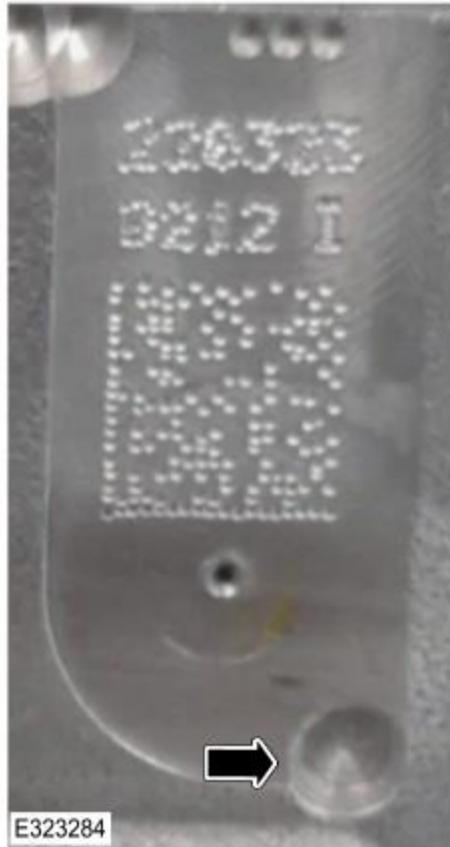
5. The failure condition shown highlights 1 drilled tooling mark in the lower right side of the tooling stamp.

If the 1 drilled tooling mark in the lower right side of the tooling stamp is present, then the vehicle has failed the inspection.

Vehicles which failed the inspection: Contact jlrcamp@jaguarlandrover.com and supply the full 17-digit [VIN](#) of the vehicle, **continue to quarantine the vehicle and wait for further instructions.** DO NOT submit a claim for the inspection, instructions for claiming the inspection that failed will be given with the repair process.

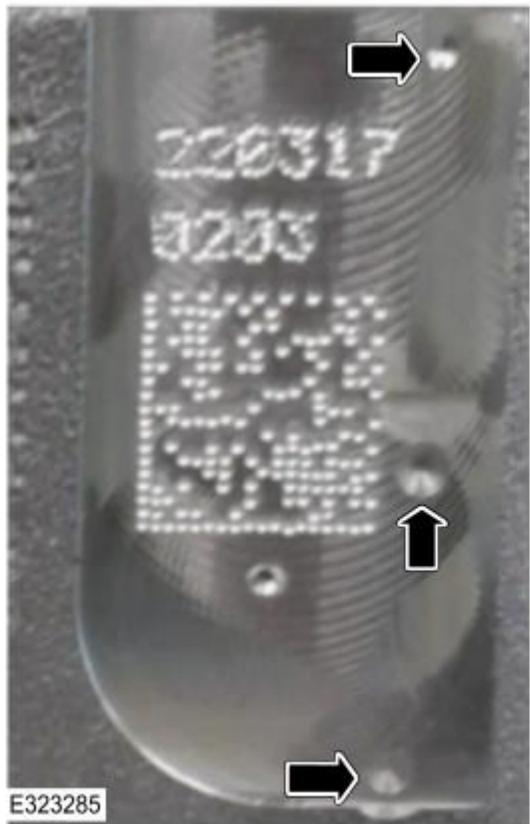
6. The failure condition shown highlights 3 drilled tooling marks in the upper, middle and lower right side of the tooling stamp.

If the 3 drilled tooling marks in the upper, middle and lower right side of the tooling stamp are **ALL** present, then the vehicle has failed the inspection.

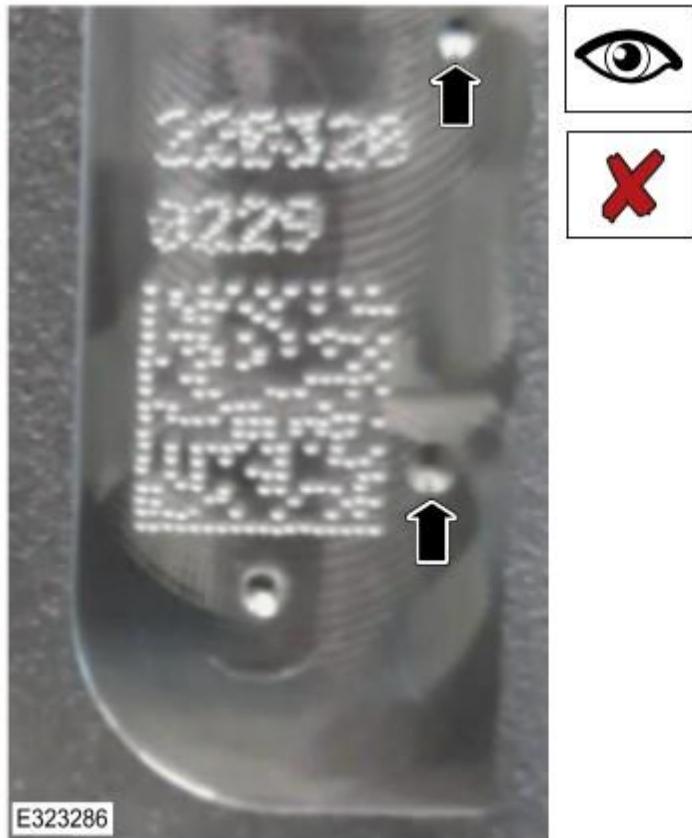
7. The failure condition shown highlights 2 drilled tooling marks in the upper and middle right side of the tooling stamp.

If the 2 drilled tooling marks in the upper and middle right side of the tooling stamp are **BOTH** present, then the vehicle has failed the inspection.
