# UPDATE PRIOR TO SALE NOTICE

Global Service Action  
Number: N763 UPS8522-3

Subject:  <h2>Camshaft Carrier Drill Hole</h2>	Publication No.: N763 UPS8522-3
	Model: Range Rover (LK)
	Model Year: 2023
	Model: Range Rover Sport (L1)
	Model Year: 2023
	Model: Discovery (LR)
	Model Year: 2023
	Model: Defender (LE)
	Model Year: 2023
	Model: Range Rover Velar (LY)
	Model Year: 2023 - 2024
	Date of Issue: 09 December 2022
	Expiry Date: 09 December 2023

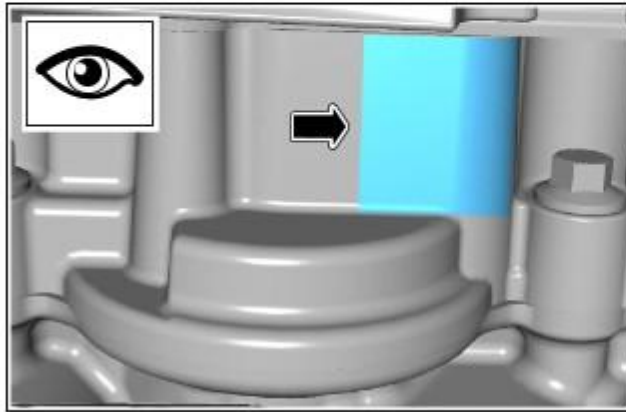
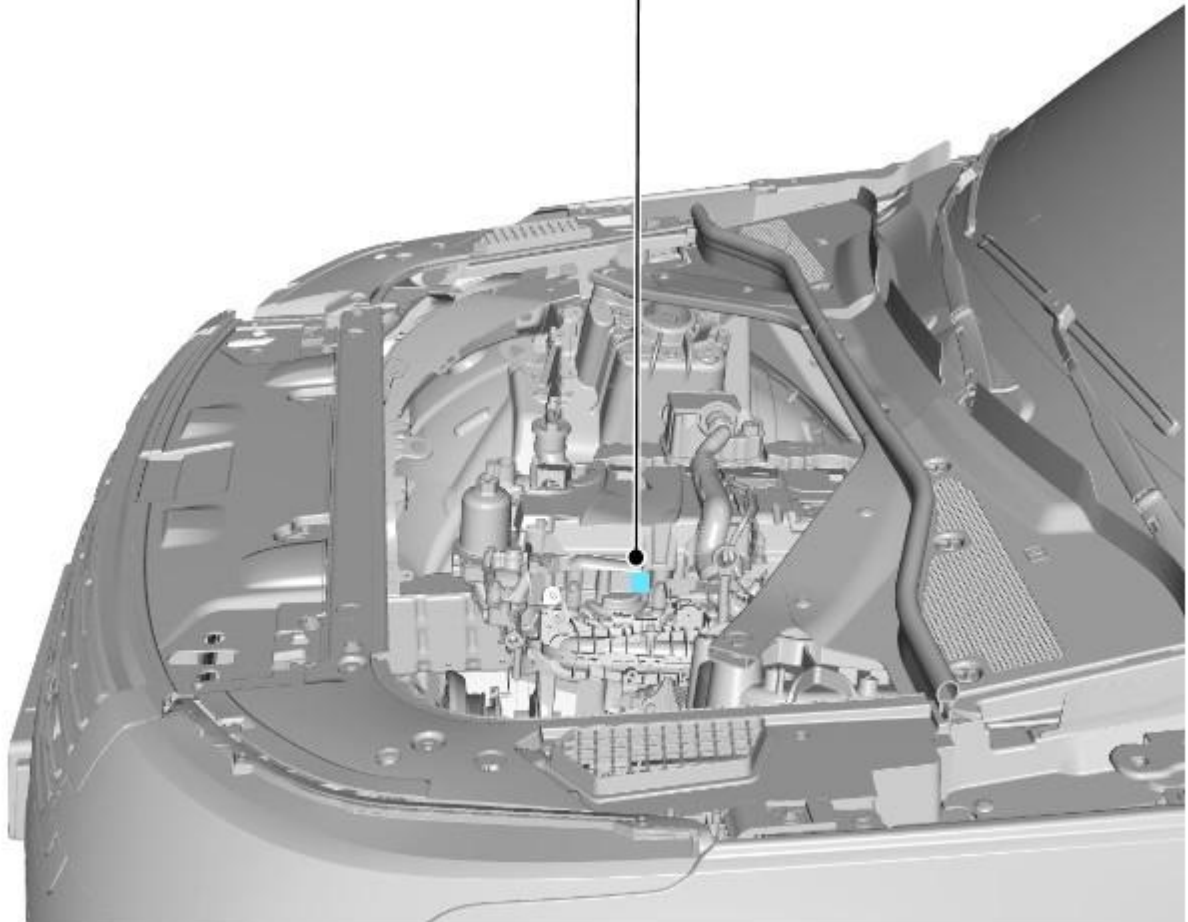
E323282

2. Locate the highlighted area of the camshaft carrier shown in the illustration.

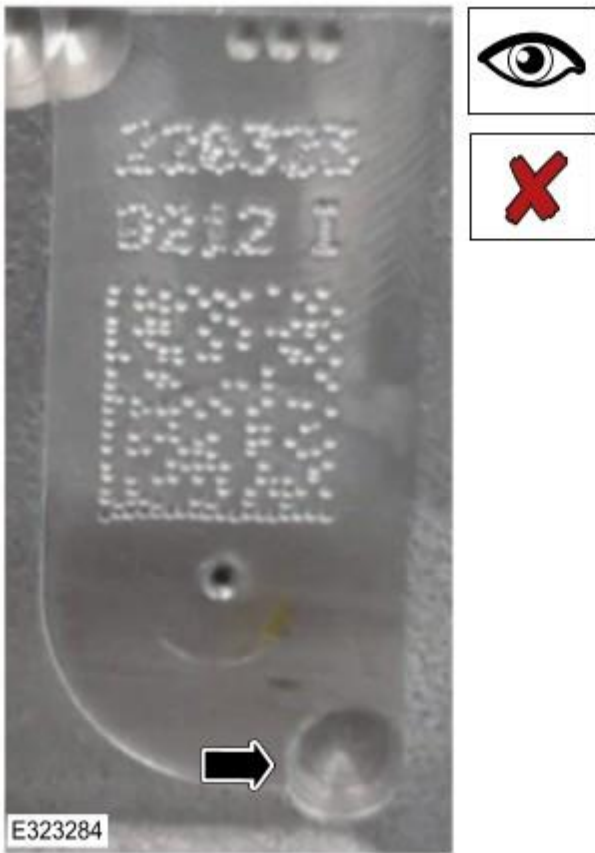
- 5. The failure condition shown highlights 1 drilled tooling mark in the lower right side of the tooling stamp.

If the 1 drilled tooling mark in the lower right side of the tooling stamp is present, then the vehicle has failed the inspection.

**Vehicles which failed the inspection:** Contact [jlrcamp@jaguarlandover.com](mailto:jlrcamp@jaguarlandover.com) and supply the full 17-digit [VIN](#) of the vehicle, **continue to quarantine the vehicle and wait for further instructions.**

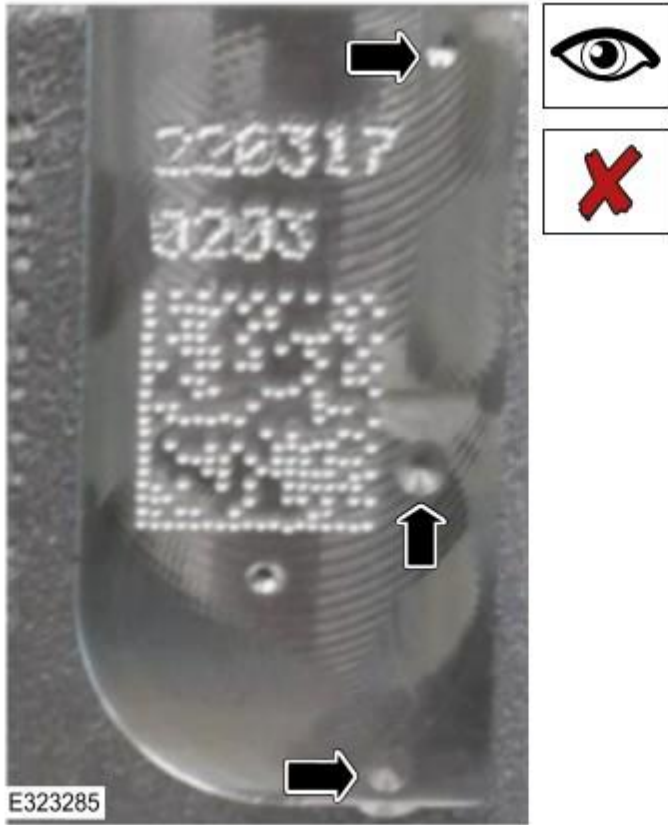
- 6. The failure condition shown highlights 3 drilled tooling marks in the upper, middle and lower right side of the tooling stamp.

If the 3 drilled tooling marks in the upper, middle and lower right side of the tooling stamp are **ALL** present, then the vehicle has failed the inspection.

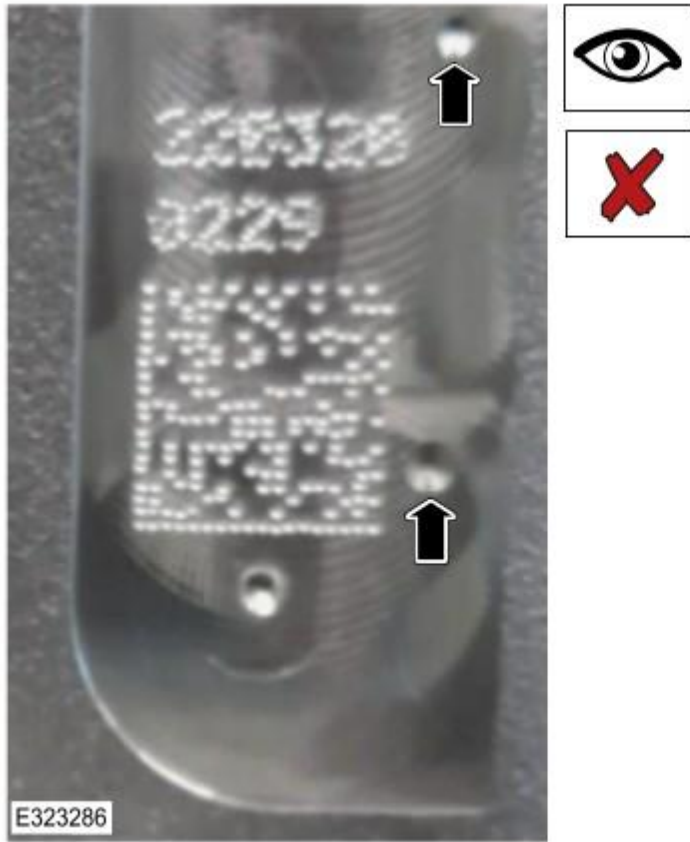
- 7. The failure condition shown highlights 2 drilled tooling marks in the upper and middle right side of the tooling stamp.

If the 2 drilled tooling marks in the upper and middle right side of the tooling stamp are **BOTH** present, then the vehicle has failed the inspection.
