## STAR ONLINE PUBLICATION

**Case Number:** S2223000026

**Symptom/Vehicle Issue:** Front Tire Rub On Fender Liner Splash Shield

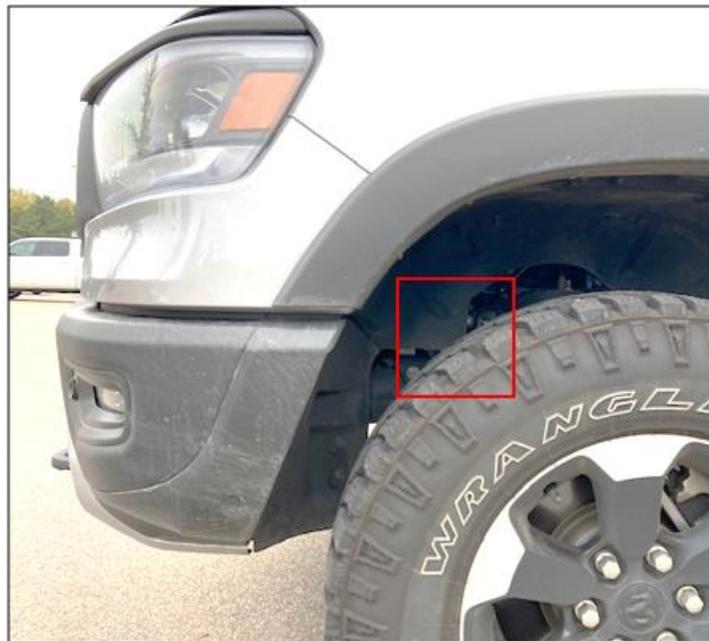
**Discussion:** If a customer states there is a rubbing, clunking, or rattle noise on tight turns while cornering, inspect the above area for signs of contact with the tire. If rub marks exist on the splash shield it is not necessary to replace it. Using hand pressure over bend and adjust the shield away from the tire in the diagonal area shown in the image below.
