STAR ONLINE PUBLICATION

Case Number: S2108000165 Rev. A

Symptom/Vehicle Issue: MIL Lamp Is On, Multiple Glow Plug DTC's

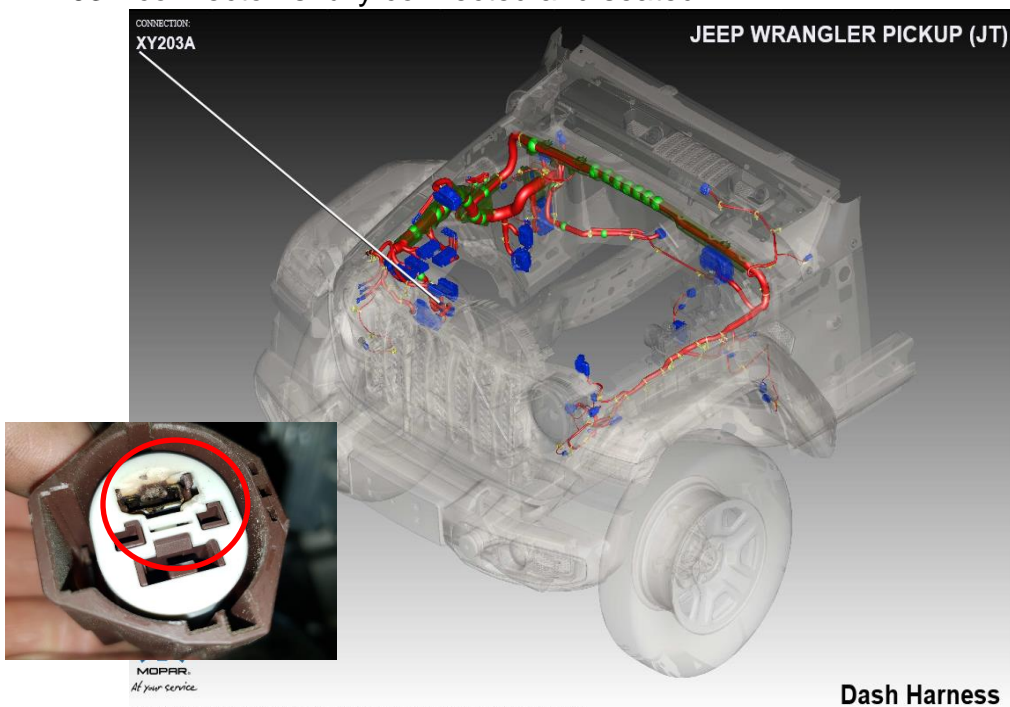
Fig 1

Customer Complaint/Technician Observation: Owner complains that the MIL (Malfunction Indicator Lamp) lamp is on in the cluster. Technician Observed the vehicle may have set multiple DTC's P052F-00 GLOW PLUG CONTROL MODULE 1 SYSTEM VOLTAGE, P0671, P0672, P0673, P0674, P0675, P0676-CYLINDER 1-6 GLOW PLUG CIRCUIT OPEN.

Repair Procedure: With multiple glow plug DTC's, inspect the main B+ feeds and grounds to the GLOW plug module prior to any other repairs. Review inline connector XY203A Brown/2way for the A29 circuit, and/or perform a voltage drop test to identify any loss of power supply if needed Fig 1, 2. Verify the XY203A connector is fully connected and seated.
