JLRTB02109NAS2
TECHNICAL BULLETIN
22 DEC 2022

412-01

Air Conditioning (A/C) Inoperative

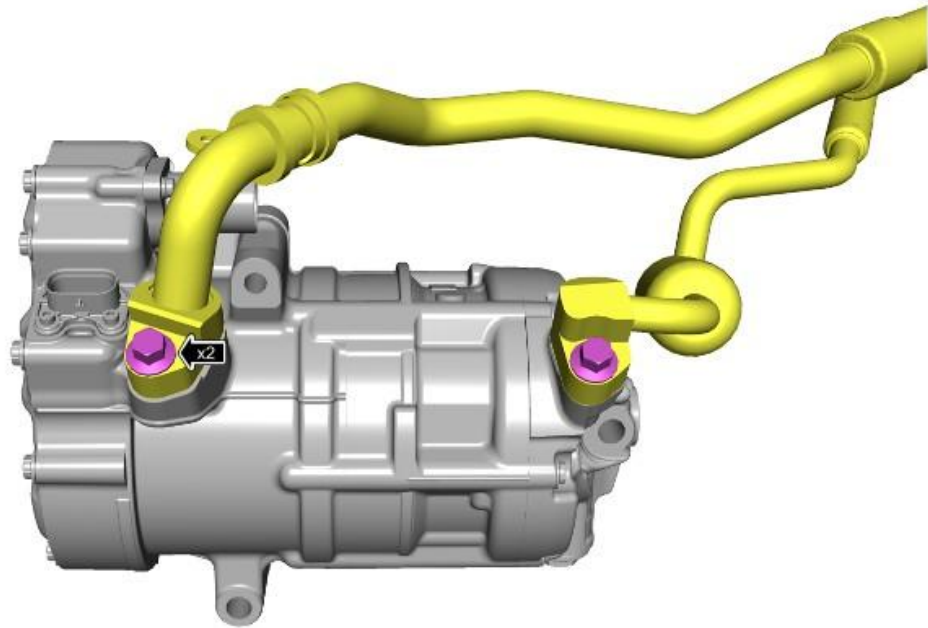
9.

Disconnect both A/C pipes from the A/C compressor.

- Remove the 2 bolts.
 - Torque: **24 Nm**
