Revision (1) December 2022

Customer Satisfaction Notification Z60 Powertrain Control Module Software

2021-2022 (JT) Jeep® Gladiator

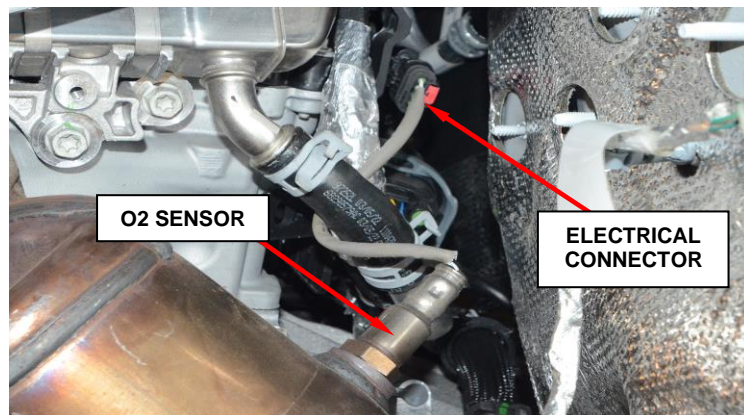
Figure 2 – O2 Sensor Electrical Connector

CAUTION: When disconnecting the oxygen sensor electrical connector, do not pull directly on the wire going into the sensor. The sensor wiring can be damaged resulting in sensor failure.

1. Disconnect and isolate the negative battery cable(s)
2. Remove the front wheel.
3. Remove the splash shield screws (Figure 1).
4. Remove and discard the push pin fasteners (Figure 1).
5. Remove the rivets securing the splash shield to the flare molding (Figure 1).
6. Unlock and disconnect the left/right downstream O2 sensor wire harness connector (Figure 2).

7. Remove the left/right downstream O2 sensor and **DISCARD**.
8. If necessary, clean the threads in the exhaust pipe using appropriate tap.
9. Hand start threading the **NEW** O2 sensor and tighten to 43N·m (32ft. lbs.).
10. Reconnect the O2 sensor electrical connector (Figure 2).
11. Align and install the splash shield to the wheel opening (Figure 1).
12. Install **NEW** rivets (Figure 1).
13. Install **NEW** push pin fasteners (Figure 1).
14. Install the screws and tighten to 5N·m (44In. lbs.) (Figure 1).
15. Install the wheel and tire assembly and tighten to 176N·m (130ft. lbs.).
16. Proceed to section **A. Reprogramming PCM Procedure.**
