NUMBER: 08-046-14 REV. A

Power Window-Vent Switch - Interim CSN Repair

2010-2014 (RT) Town and Country/Grand Caravan
(Left Hand Drive only)

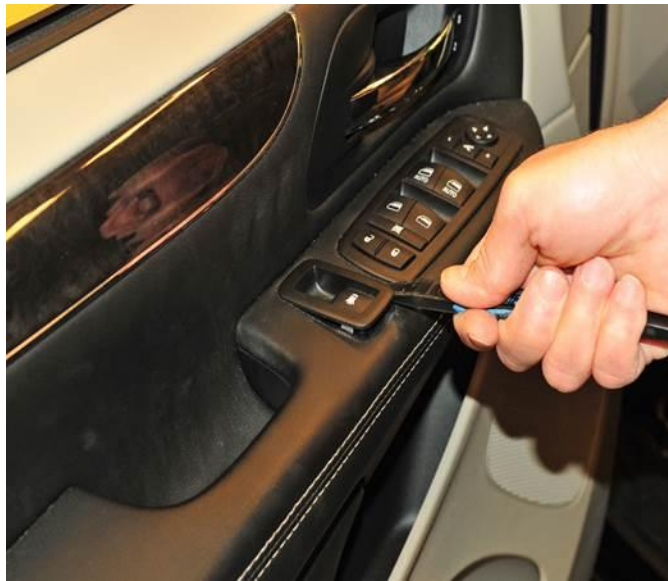
Fig. 1 Removing Window Vent Switch

A customer may inquire about Safety Recall P25 and request to have their Power Quarter Vented Window Switch disconnected or a customer may have noticed a burning odor or have seen smoke coming from the power vented window switch on the drivers door. Once the proper amount of parts are available, all of the customer will be notified. In the meantime, the switch can be disconnected, to satisfy the customer.

1. Remove the switch from the drivers door arm rest, using a proper trim stick.

Use the proper trim tool to remove the switch.

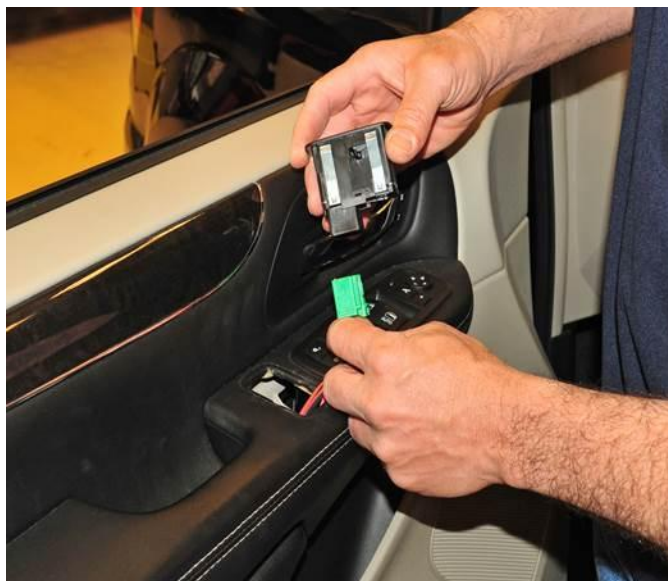
Fig. 2 Unplug Connector from Vent Switch

Green connector

2. Disconnect the connector from the switch.

3. Push the connector through the open cavity in the door. Position it so it will not interfere with the switch when reinstalled.
4. Reinstalled the disconnected switch.
5. Return the vehicle to the customer and advise them they will be notified when the switch is available.
