NUMBER: 23-037-14

Wind Noise At The Left And/Or Right Door

2015 (LA) Dodge Challenger

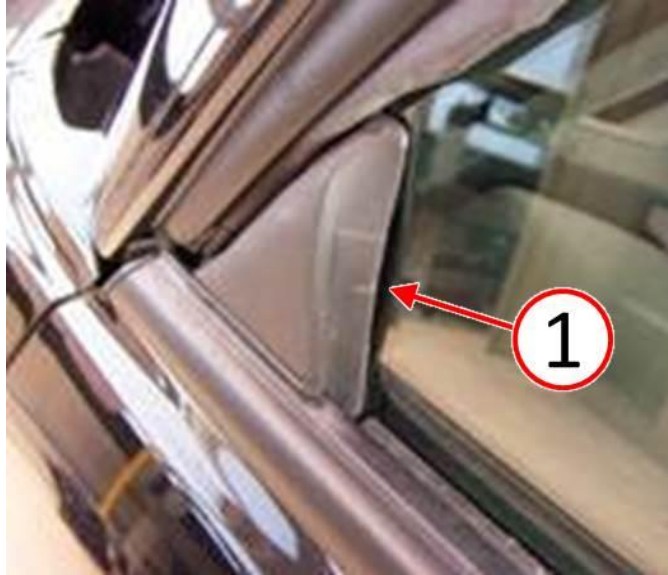
Fig. 1 Window Flag Gap Inspection

1. Raise the door window glass to the full up position.
2. Inspect both doors for a gap between the outer door mounted window seal flag and the door window glass (Fig. 1).

1 - Gap

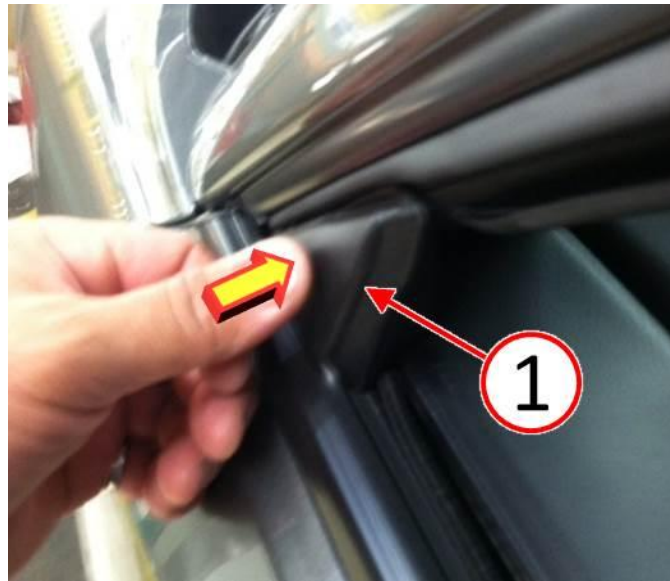
Fig. 2 Push In On The Window Flag

1 - Seal Flag

-
3. Is there a gap between the outer door mounted window seal flag and the door window glass?
 - a. YES>>> Continue with the Repair Procedure.
 - b. NO>>> This Bulletin does not apply. Further diagnosis is required.
 4. Fully lower the door window glass.
 5. Apply slight pressure to the outboard side of the seal flag. This will reposition the metal tab inside the seal flag moving the seal flag tighter to the glass surface (Fig. 2).

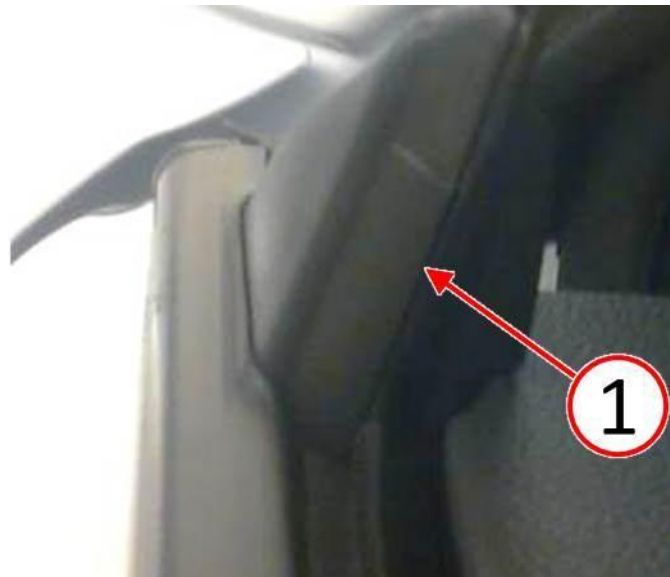
Fig. 3 Window Flag In Proper Position

1 - No Visible Gap

6. Raise the door window glass to the full up position.
7. Confirm that the gap has been eliminated between the outer door mounted window seal flag and the door window glass (Fig. 3).
