NUMBER: 23-022-14 REV. A

DATE: October 23, 2014

Tailgate Retaining Strap Over Extends And Breaks

2012 - 2014 (JK) Wrangler

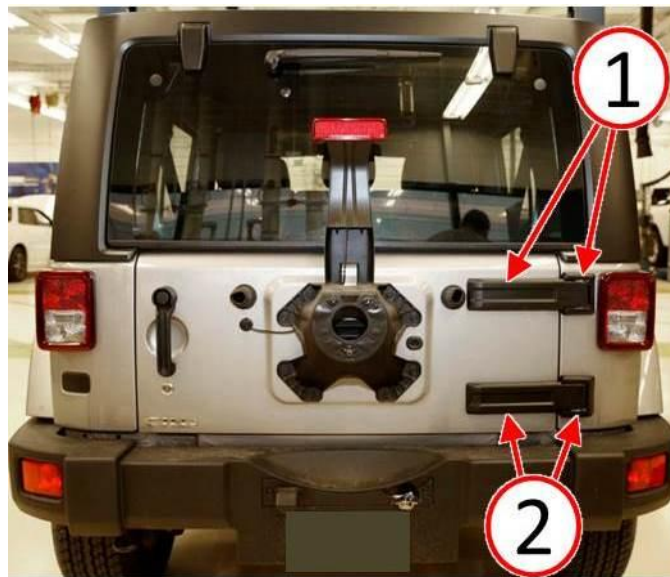
Fig. 1 Tailgate Hinge Covers

1 - Upper Hinge Covers

2 - Lower Hinge Covers

1. Paint the new replacement tailgate hinges per the approved warranty refinish paint manufacturers (Akzo Nobel, Axalta, BASF, PPG, and Sherwin-Williams) recommendations.
2. Remove the spare tire from the tailgate if applicable.
3. Remove the upper hinge covers (1) and lower hinge covers (2) (Fig. 1).

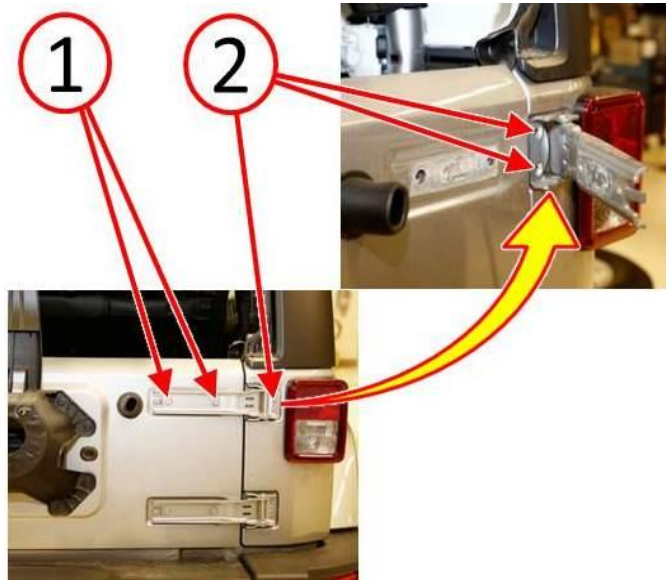
Fig. 2 Tailgate Hinges

1 - Tailgate Side Hinge Bolts

2 - Body Side Hinge Bolts

4. Replace both tailgate hinges one at a time. First remove the tailgate side hinge bolts (1) then the body side hinge bolts (2), reverse order for installation (Fig. 2). Apply body sealant per manufacturer's directions to the back surface of the hinge where it makes contact with the vehicle to prevent corrosion (Fig. 3). Refer to the detailed repair procedures available in: DealerConnect> TechCONNECT under: Service Info> 23 - Body> Decklid/Hatch/Liftgate/Tailgate> HINGE> Removal / Installation.

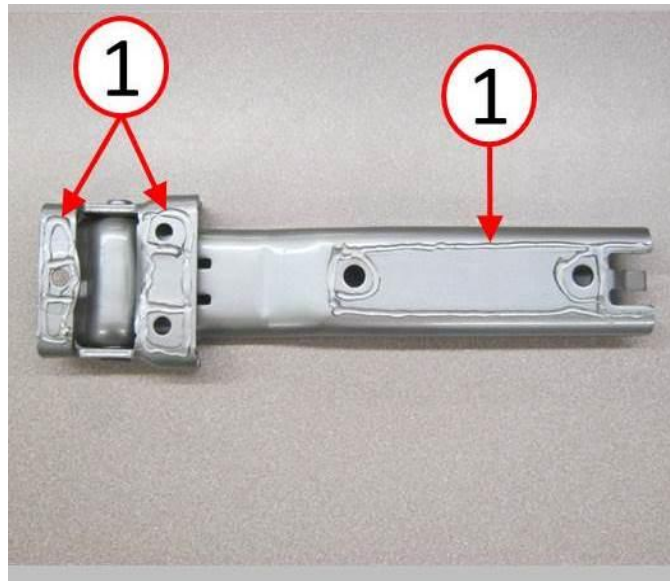
Fig. 3 Tailgate Hinge Body Sealer Application

1 - Body Sealant Application

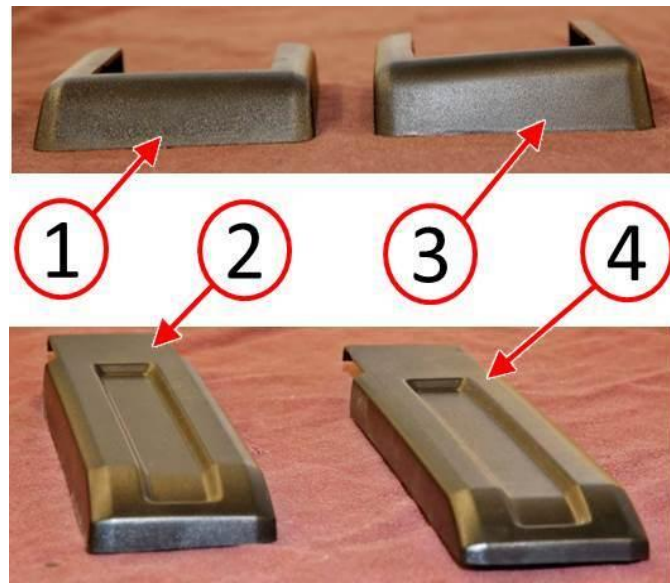
Fig. 4 Tailgate Hinge Cover Identification

- 1 - Lower Body Side Hinge Cover
- 2 - Upper Tailgate Side Hinge Cover
- 3 - Upper Body Side Hinge Cover
- 4 - Lower Tailgate Side Hinge Cover

5. Install the tailgate hinge covers. If the hinge cover(s) were damaged due to tailgate hinge over extension, replace the damaged hinge cover(s) as necessary. Each hinge cover is a unique shape and **CANNOT** be interchanged. Refer to (Fig. 4) for identification of correct hinge cover placement.

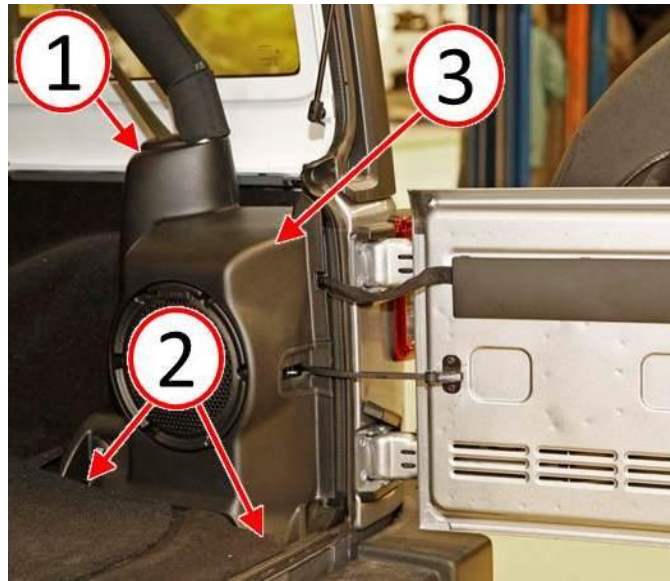
Fig. 5 Right Rear Quarter Trim Panel

- 1 - Quarter Trim Bezel
- 2 - Fasteners
- 3 - Quarter Trim Panel

-
- 6. Install the spare tire to the tailgate if previously removed.
 - 7. Remove the right rear quarter trim panel (3). One fastener is located behind the trim bezel (1) and two fasteners are under the cargo floor covering at location (2) (Fig. 5). Refer to the detailed repair procedures available in: DealerConnect> TechCONNECT under: Service Info> 08 - Electrical> 8A - Audio/Video/Entertainment/Connectivity> SPEAKER> Removal> SUBWOOFER. Quarter trim panel without subwoofer requires a similar removal process but without speaker electrical connector.

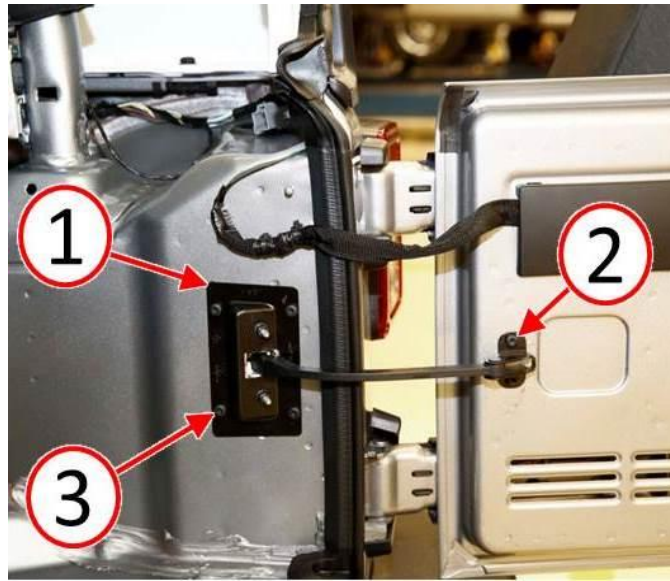
Fig. 6 Tailgate Retaining Strap

The tailgate retaining strap is damaged due to the tailgate hinge over extending. The retaining strap typically breaks at the body side of the retaining strap attachment. Tailgate hinge covers and/or tail lamp may also be damaged as a result of over extension.

- 1 - Retaining Strap
- 2 - Body Side Fasteners
- 3 - Tailgate Side Fasteners

-
8. Remove the two retaining strap to tailgate fasteners (2) and four retaining strap to body fasteners (3) then remove the tailgate retaining strap (1) from the vehicle ([Fig. 6](#)).

-
9. Install the new tailgate retaining strap (Fig. 6).
 10. Install the right rear quarter trim panel (Fig. 5). Refer to the detailed repair procedures available in: DealerConnect> TechCONNECT under: Service Info> 08 - Electrical> 8A - Audio/Video/Entertainment/Connectivity> SPEAKER> Installation> SUBWOOFER. Quarter trim panel without subwoofer requires a similar installation process but without speaker electrical connector.
 11. If the right side tail lamp was damaged due to tailgate hinge over extension, replace the tail lamp. Refer to the detailed repair procedures available in: DealerConnect> TechCONNECT under: Service Info> 08 - Electrical> 8L - Lamps and Lighting> Lamps> Lighting - Exterior> LAMP, Tail Stop Turn> Removal / Installation.
