STAR ONLINE PUBLICATION

Case Number: S2123000028

Release Date: May 2021

Symptom/Vehicle Issue: Noise From Under Seat With Occupant Seated.

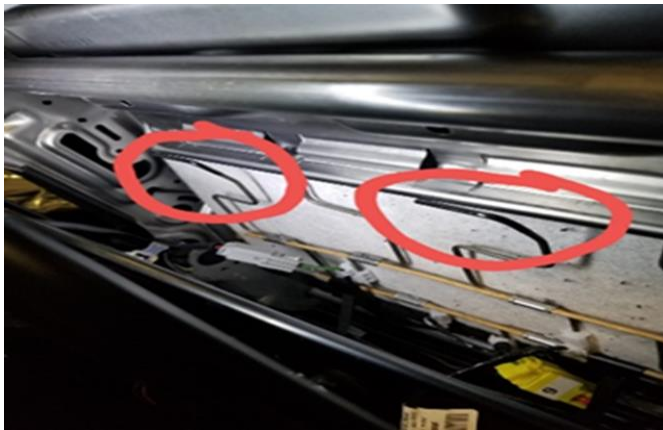
Discussion: Some customers may experience a noise from under the front seat when sitting on cushion. Upon further investigation, a technician may notice the Flex Mat is not secured.

Fig 1 Mat Not Seated

If you experience this condition, please review the seat from the bottom front to ensure that the flex mat wires (4 locations) are properly seated to the cushion pan. If they are not seated (Fig 1), lift the trim and foam to hook wires into cushion pan properly (Fig 2)

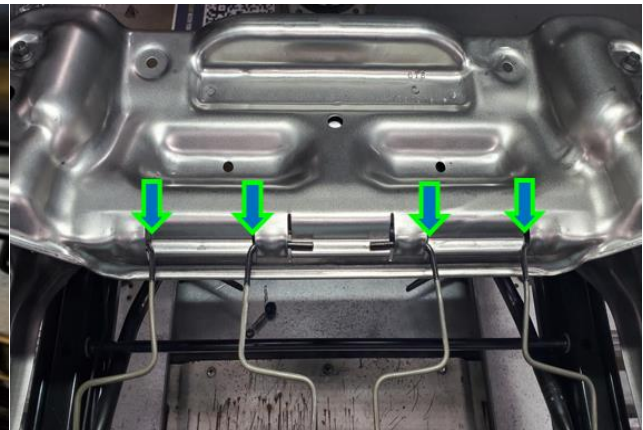
Fig 2 Mat Properly Seated
