## STAR ONLINE PUBLICATION

**Case Number:** S1925000008 REV. C

**Symptom/Vehicle Issue:** Malfunction Indicator Lamp (MIL) Illumination. Diagnostic Trouble Codes (DTCs) P208B – Reductant Pump 1 Control Performance, and/or P20E8 – Reductant Pressure Too Low, Set.

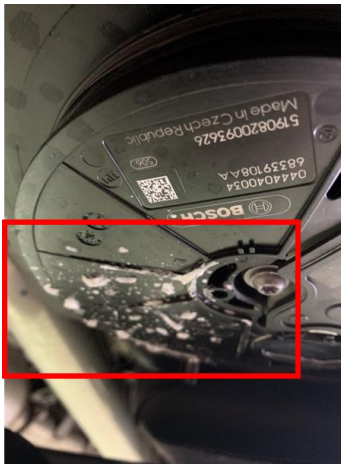
Figure 1.

2. Closely inspect the DEF supply line connections at the pump and injector to ensure there are no leaks. Look for signs of wetness, and/or crystallization around the connections indicating a leak. Please see (Figure 1, and 2.). Repair any leaks before proceeding with the rest of this procedure.
