**TECHNICAL INSTRUCTIONS**  
**FOR**  
**CUSTOMER SUPPORT PROGRAM 22TE09**  
**HV FLOOR UNDER WIRE HARNESS AND REAR TRACTION MOTOR CABLE**  
**CORROSION**  
**CERTAIN 2019 –2022 MODEL YEAR RAV4 HYBRID AWD**

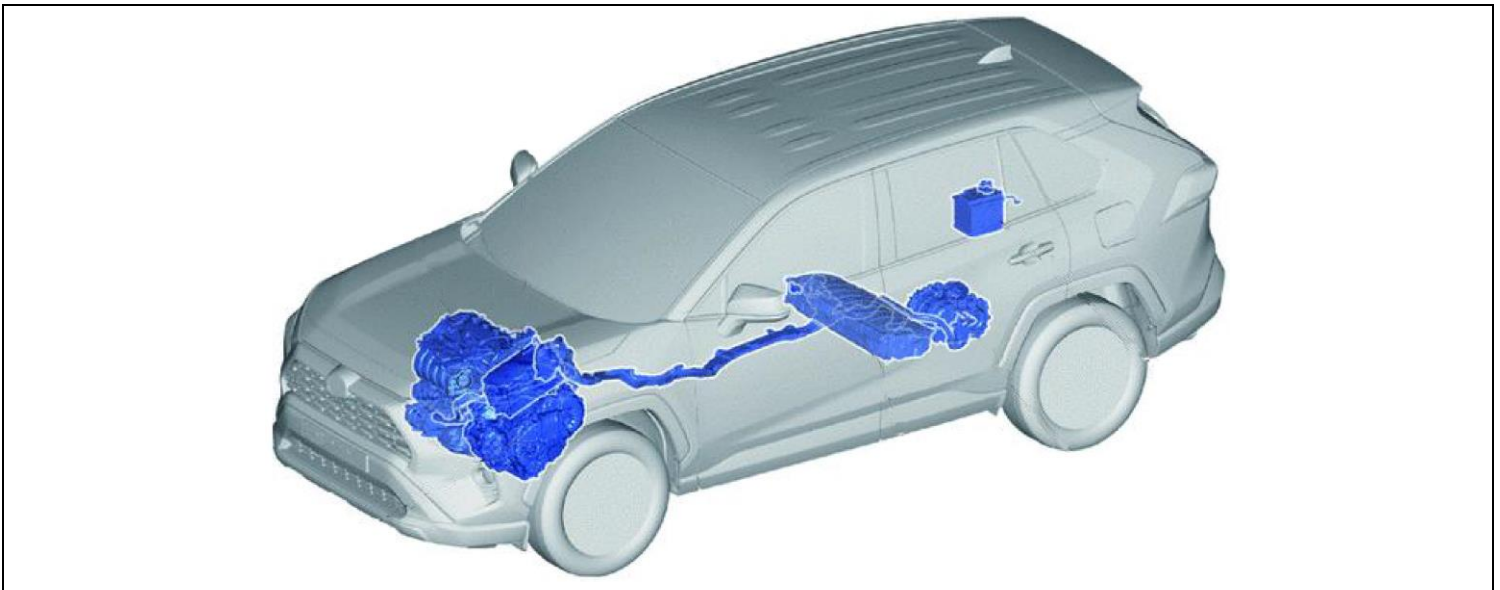
Although the HV Floor Under Wire Harness and Rear Traction Motor Cable is covered by Toyota's New Vehicle Limited Warranty for 3 years or 36,000 miles (whichever comes first), we at Toyota care about the customers' ownership experience. Toyota is providing coverage for repairs related to excessive corrosion to the wire harness connections at the Rear Motor Generator. Excessive corrosion can cause AM Radio Static during certain drive cycles or the vehicle may not start.

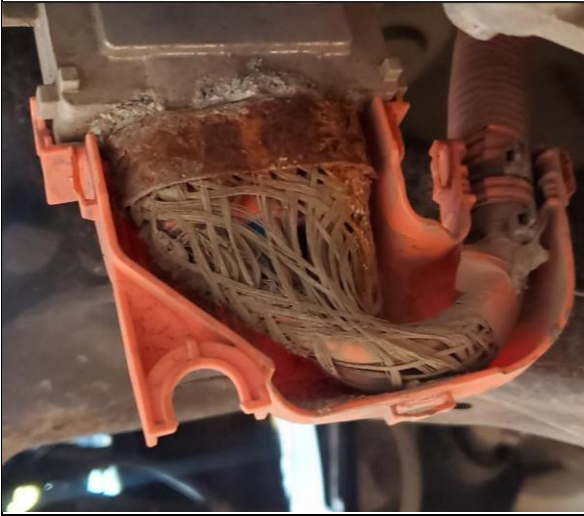
**Y6 connector under vehicle at MGR**

- 5) Inspect the Y6 connection for corrosion  
f) Disconnect the Y6 connector at the MGR and inspect for corrosion, dirt, or debris.

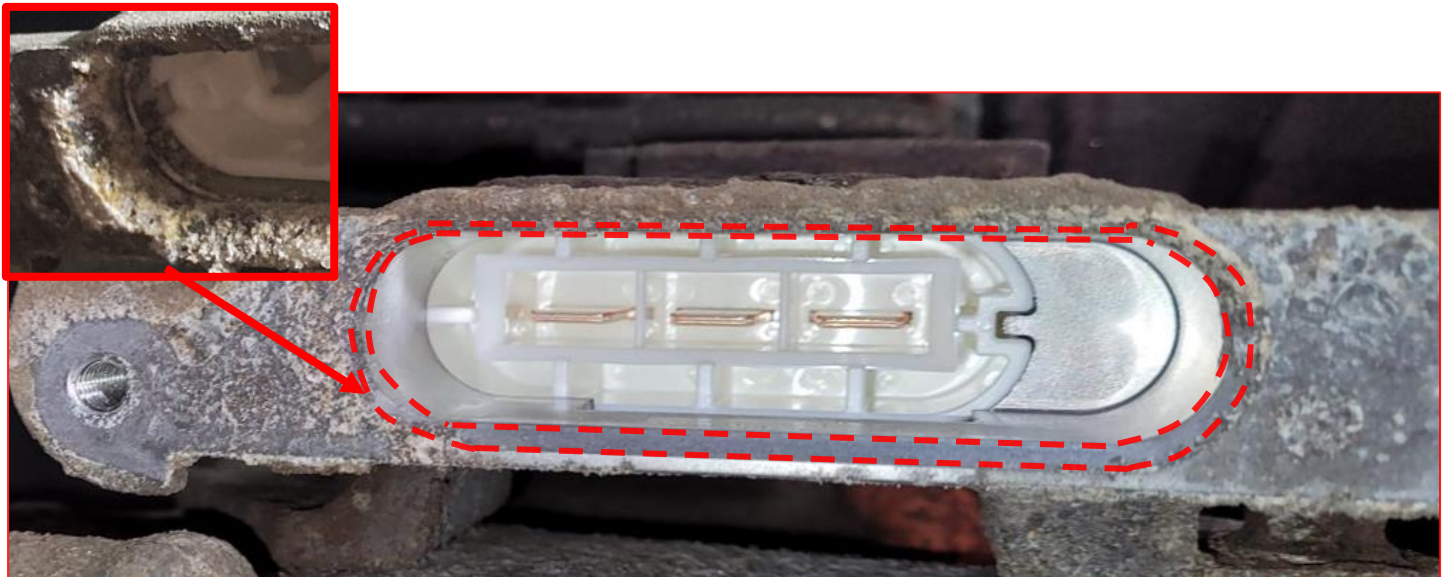
- a) Inspect the chamfer of the MGR connector housing for pitting and corrosion on the sealing surface. Corrosion in this area will cause the seal to leak. Is pitting and corrosion present?

**YES** – Rear Traction Motor Cable requires replacement continue to Section VI
