Service Bulletin

Bulletin No.: 20-NA-047

Subject: Front or Rear Crankshaft Oil Leak, Malfunction Indicator Lamp (MIL) Illuminated - DTC P1101 Set

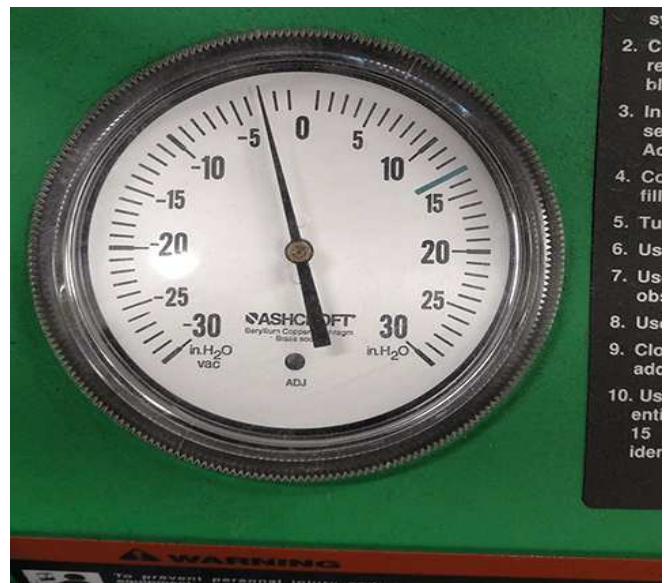
4573243

Normal crankcase pressure readings for the L3A, LE2, LFV and LYX are between -1 & -5 inches of water in park at hot idle.

- If the crankcase pressure is in the proper range, follow Strategy Based Diagnostics for engine oil leaks and/or P1101 per SI.
- If the crankcase pressure is excessively positive, above 0 inches of water (0 inches of HG / vacuum), then a positive crankcase pressure concern exists requiring further diagnostics.

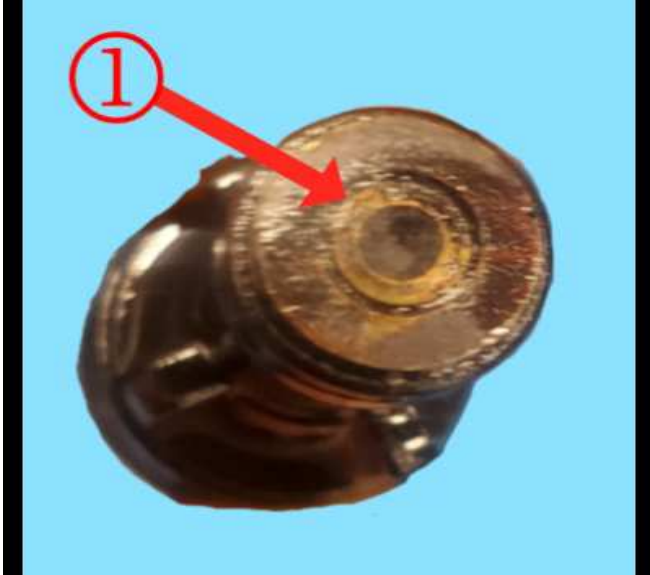
5513764

If diagnosing for oil leaks and/or DTC P1101 with no engine oil leaks and excessive positive crankcase pressure exists, an obstructed PCV orifice (1) would be suspect requiring a PCV orifice replacement.

Remove the camshaft cover and remove the PCV orifice and inspect for blockage. Replace the orifice as necessary along with the camshaft cover gaskets. Make sure the camshaft cover does not have any blockages in the PCV passages.
