# Technical Service Bulletin

## 30 Various DTCs stored in the TCM and/or running problems - high maximum temperature recorded for clutch K1

30 23 32 2060560/2 January 12, 2023. Supersedes Technical Service Bulletin Group 30 number 20-29 dated August 31, 2020, for reasons listed below.

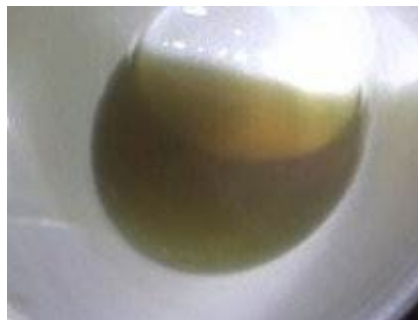
3. Check the transmission fluid by obtaining a sample of the transmission fluid drained in to a white cup. Approximately one inch of transmission fluid in the cup is all that is required. Take a photograph of the fluid with the cup tilted at about 45 degrees for your records (Figure 2). It may be needed if an Audi Technical Assistance Center (TAC) case needs to be opened or for warranty purposes.

**Figure 2.** Fluid photograph example showing approximately one inch of fluid in the white cup, and tilted on an angle to show depth and color.

4. If the measured value for Clutch 1 maximum temperature is about 400 degrees Celsius and the transmission fluid smells burnt and is black or very dark in color, then replace the dual clutch, the transmission fluid, and the transmission filter per the repair manual.
5. If the clutch 1 maximum temperature is not close to 400 degrees Celsius and the transmission fluid is not black or very dark in color then this TSB does not apply. Open an Audi Technical Assistance Center (TAC) case with pictures of the transmission fluid picture attached and your diagnosis information. Then contact the Audi Technical Assistance Center (TAC).
