Technical Service Bulletin

51 Visible corrosion at joint between roof and roof side member

51 23 26 2068999/1 January 5, 2023.

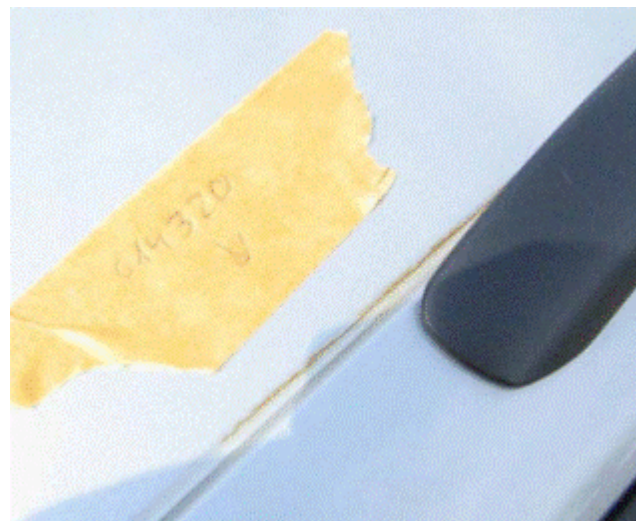
The corrosion may have begun as a result of the underlying metal being exposed and unprotected to the elements due to a crack in the paint top coat. Cracks in the paint in the area of the roof channel seams are likely due to the roof panel having sustained impact externally from objects such as a large snow load falling from above, a cargo carrier, or its contents having come in contact with the roof panel, hail storm, etc. The result of any impact will cause microscopic cracks in the paint in the roof channel seams, and over time, cause corrosion in the roof metal after a prolonged period unprotected if this damage is not repaired according to Audi collision repair guidelines immediately after the event. Repairs to the roof panel after an impact event, such as paintless dent removal, will leave a characteristic wave in the roof panel and the paint cracks will remain, leaving the underlying metal unprotected and susceptible to corrosion formation.

1. Figure 1 shows an example of a typical case of corrosion formation due to paint cracking.

Figure 1. Resultant corrosion due to cracks in the paint.

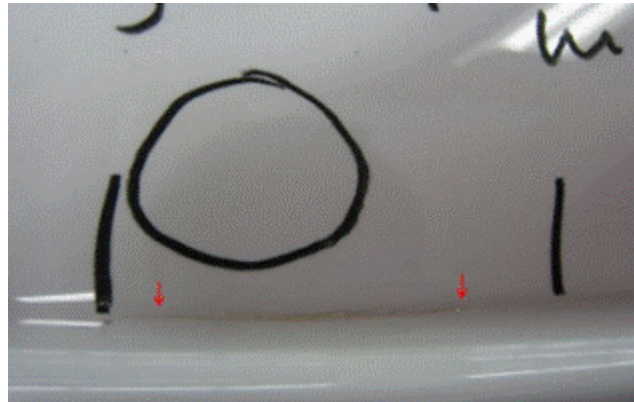
2. Figure 2 shows a closer view of the paint cracking.

Figure 2. Close-up view of paint cracking in roof channel seam.

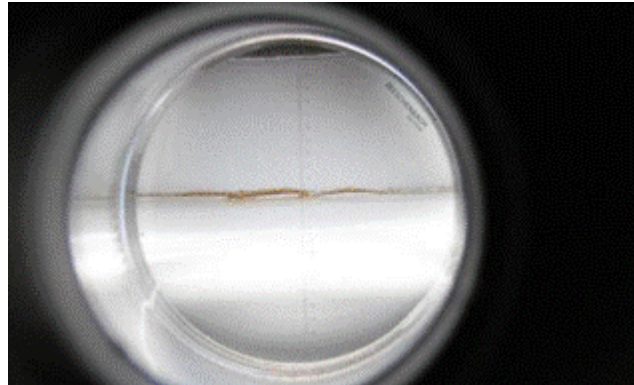
3. The roof channel seams may require viewing under magnification for detection.

Figure 3. Paint cracks under magnification.

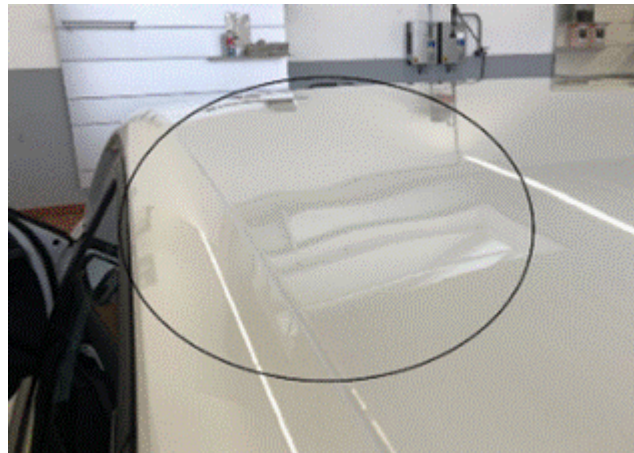
4. Any deformation of the roof panel that persists after an external force event is not likely to be visible after a cursory view of the roof panel. A more thorough examination of the roof surface will be necessary using appropriate backlighting and a reflective pattern.

Figure 4. The remaining roof deformation may evade a brief view of the roof panel.

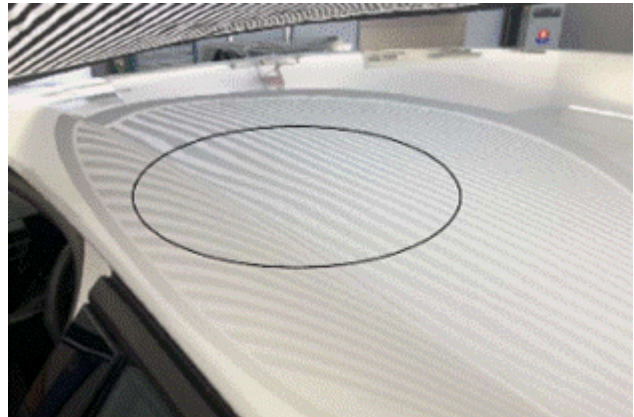
- Careful examination of the roof panel is necessary to determine any evidence of the roof panel having sustained any impact. After an impact event, there will be a characteristic waviness in the roof panel that can only be seen after careful examination of the roof surface. Use a background contrast as shown in Figure 5.

Figure 5. Roof panel examination using a contrasting pattern in the background.

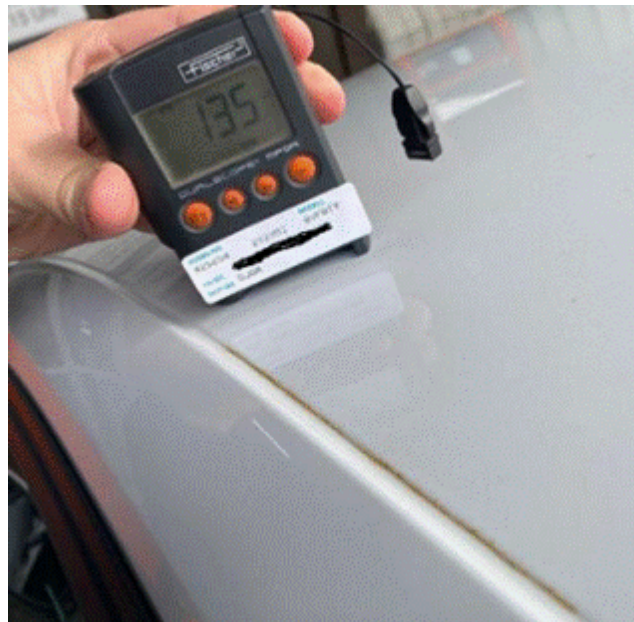
- Measure and document the paint thickness at several points along both the right and left sides of the roof panel. The ideal paint thickness range for the roof panel should be between 3.5 mm and 5.4 mm.

Figure 6. Paint thickness measurements.

- If roof deformation cannot be detected using these methods but the paint cracks are consistent with the described condition in this TSB it may be necessary to remove the headliner and carefully examine the inside of the roof panel for any persistent deformation.
- Thoroughly photo/video document the roof structure and paint inspection and document all paint thicknesses and post your findings to DocIT. In cases where no evidence whatsoever is found of the roof panel having sustained an external impact contact your AASM before performing any repair to the vehicle. Since all paint and corrosion cases must be inspected on-site by your AASM before a warranty application determination is made your field representative will corroborate this documentation and discuss further steps with Audi Warranty and Audi Product Support before rendering a final decision.
