Technical Service Bulletin

60 Panoramic sunroof opening outer perimeter seal is loose

60 23 61 2063187/2 January 9, 2023. Supersedes Technical Service Bulletin Group 60 number 21-53 dated May 7, 2021, for reasons listed below.

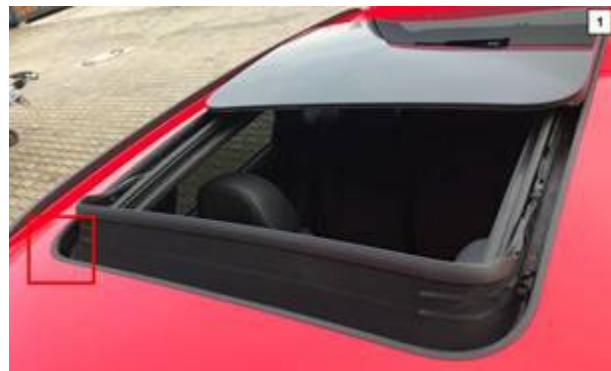
1. Begin the inspection of the sunroof opening perimeter seal adhesion by fully opening the front sunroof glass panel (Figure 1).

Figure 1. Front sunroof panel open.

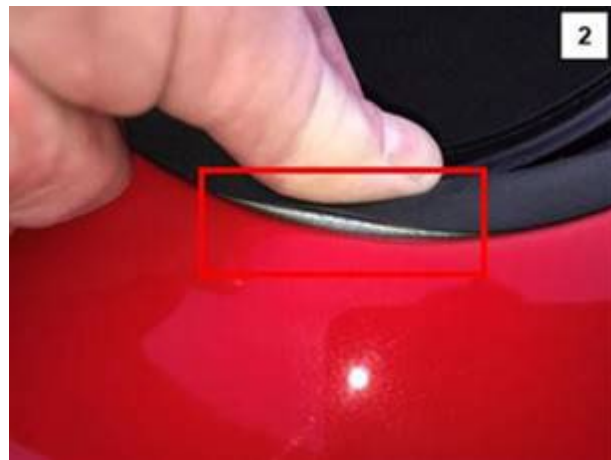
2. Press the seal downwards and inwards with your fingers until the adhesive tape for the seal is visible (Figure 2). The foam adhesive tape may be stretched but it must not be loose or detached from the roof panel to any degree.

Figure 2. Checking the adhesion quality.

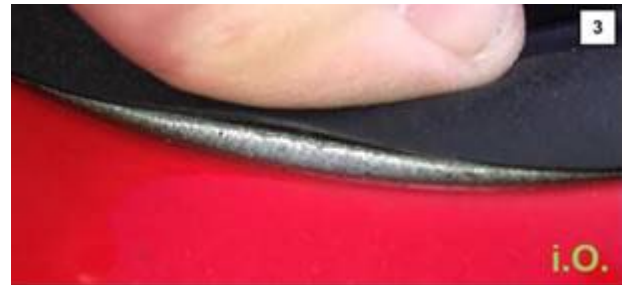
3. Figure 3 shows a properly adhered adhesive band.

Figure 3. A properly adhered perimeter seal.

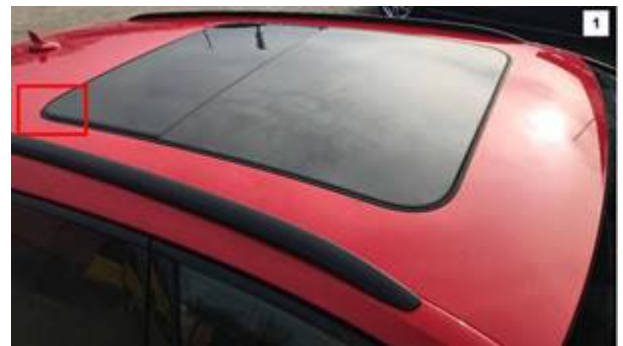
4. Repeat this procedure centimeter by centimeter over the entire length of the front sunroof opening. When this is completed, close the front sunroof panel.
5. Using the same inspection principle used in the inspection of the front portion of the sunroof opening perimeter seal check the seal adhesion in the rear portion of the sunroof opening (Figure 4).

Figure 4. Begin inspection of the rear portion of the perimeter seal.

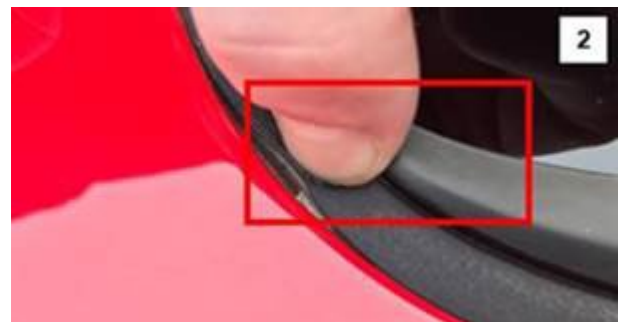
6. Figures 5 – 8 clearly show that the adhesive tape has come loose from the vehicle body. The obvious color and shape difference at the point of contact revealing the gaps is evidence of detachment.

Figure 5. Clear evidence of adhesive detachment.

7. A gap in the attachment is revealed in the examples in Figures 5 - 8.

8. The locations where the adhesion is compromised or has failed is a possible entry point for water into the cabin. The area directly below these openings is outside the area of the sunroof drainage. If any adhesion is found to be compromised or failed to any extent replace the sunroof opening perimeter seal. Follow the procedure in ElsaPro explicitly to ensure proper seal adhesion paying particularly close attention to the adhesion surface preparation.
9. Remember to set the sunroof panel and rollershade end stop adaptation after reassembly using the sunroof panel and rollershade switches. Refer to TSB 2054505: *60 Sunroof glass panel or sunroof rollershade do not operate* for instructions.

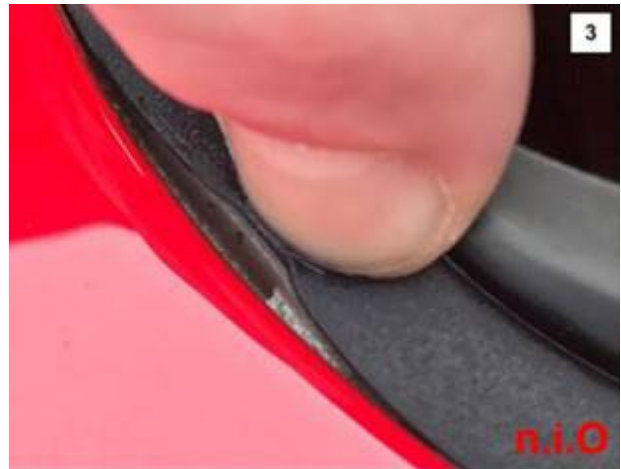
Figure 6. Seal adhesive band detachment revealed.

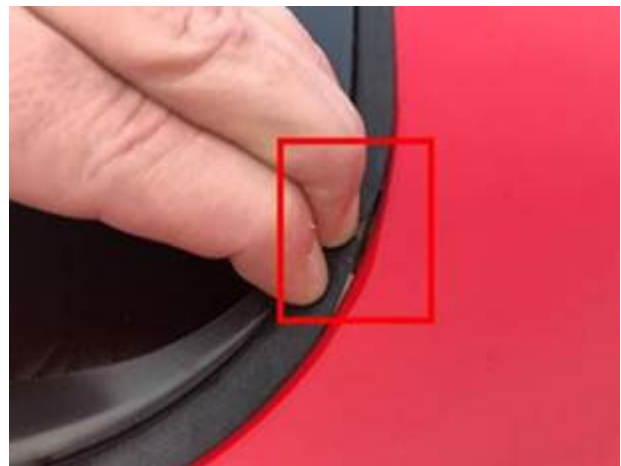
Figure 7. Adhesive band detachment.

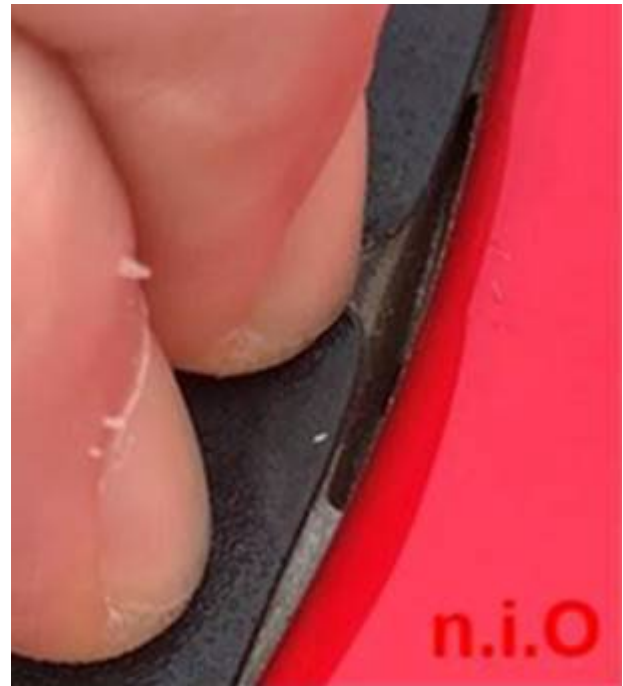
Figure 8. Close-up view of the detachment area from Figure 7.
