Preliminary Information

PIP5814 Unable To Program New RDCCM 84849877

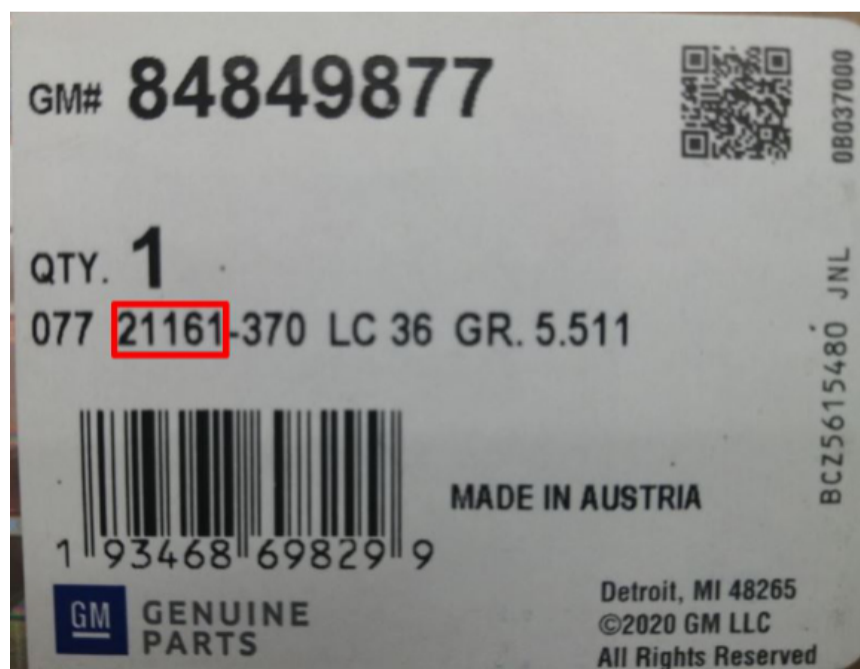
If the above conditions have been met it is possible that the module you installed was missing internal files to allow programming.

Verify the date code on the shipping label to be between 21103 and 21183 as shown below.

A part alert was sent to GM PDC and all suspect parts at the PDC were returned however parts in dealer inventory could still be suspect. If you find any of these parts within this date range please return them to CCA.
