Preliminary Information

PIT5800B Service Theft Deterrent System / SES MIL / Fuse F49DR Open / DTCs B113C, B13AC, B1AC3, B195D, B195E, U3018, U3501

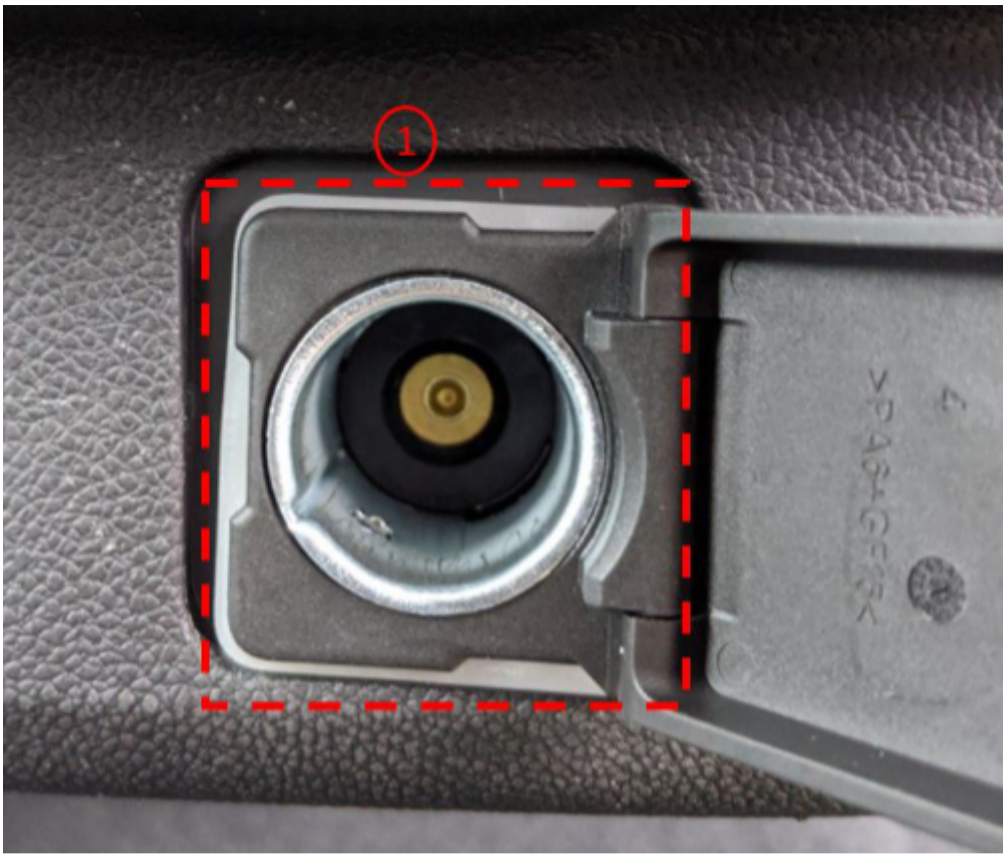
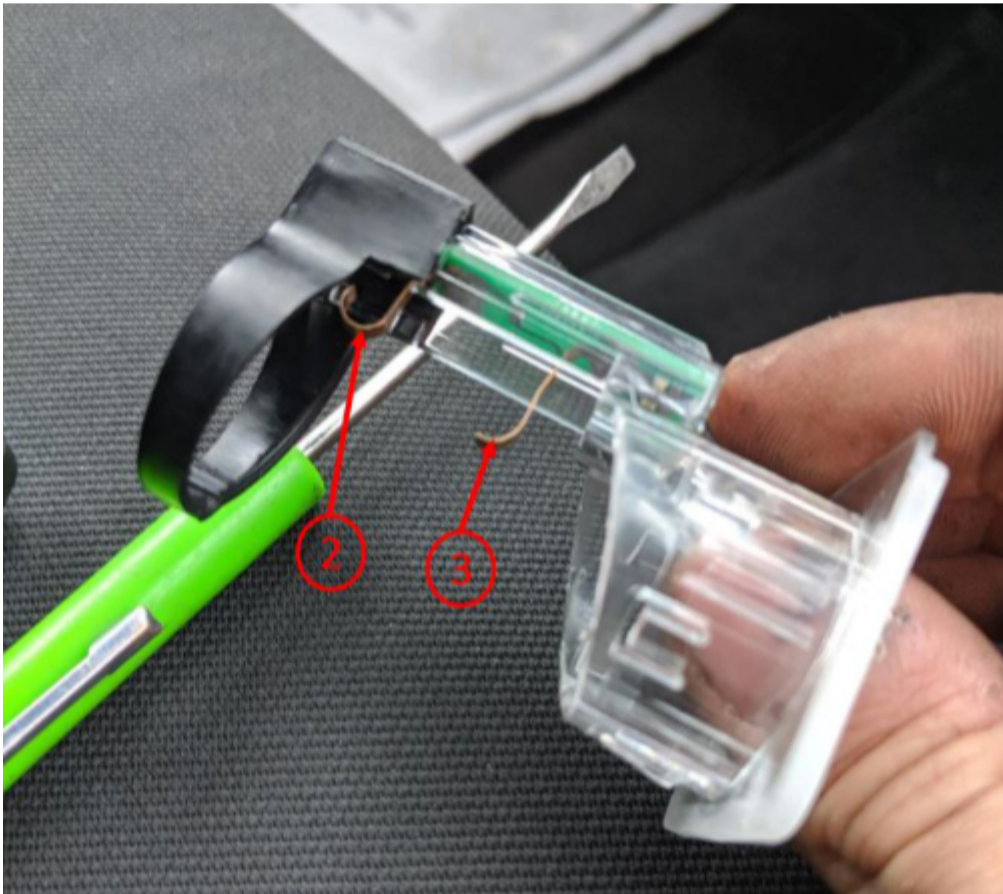
Involved Region or Country	North America
Condition	Some customers may comment on a SES MIL and a Service Theft Deterrent System message displayed in the DIC. When checking for DTC's, any of the following DTC's may be set: B113C, B13AC, B1AC3, B195D, B195E, U3018 and/or U3501. Also, fuse F49DR in the right IP fuse block will be open.
Cause	One possible cause of this condition is a short in the 12 volt power accessory illuminated ring. The 12 volt power accessory ports X80G or X80H have a LED illuminated ring around the perimeter (1), shown below. The LED illuminated ring is part of the 12 volt accessory port receptacle retainer, see 2nd photo. The 12 volt accessory port receptacle retainer has two contact tabs for the LED illuminated ring (2 and 3) which mate to the 12 volt accessory port receptacle (5 and 6), see 3rd photo. Tab 2 is for the power to the LED illuminated ring circuit 6817 and tab 3 is the ground which should only contact the outer metal body (6) of the 12 volt accessory port receptacle. If tab 3 is improperly formed or gets bent during service, it can short out between the metal body (6) and the slide contact (5) for tab 2, as shown below in call out 4. Tab 3 should only contact the metal body of the 12 volt accessory port receptacle (6).

Following SI, remove the 12 volt power accessory port X80G or X80H and inspect grounding tab 3. If the tab is shorting out between the metal body (6) and slide contact (5) for tab 2 then replace the 12 volt Accessory Power Port Receptacle Retainer.
