Bulletin No.: PIP5894 Published date: 12/15/2022

# PIP5894 Diagnostic Aids For Transfer Case Actuator Alignment

Brand:	Model:	Model Years:	VIN:		Engino	Transmissions
			from	to	Engine:	Transmissions:
Chevrolet	Silverado MD 4500 5500 6500	2019 - 2023	All	All	All	All

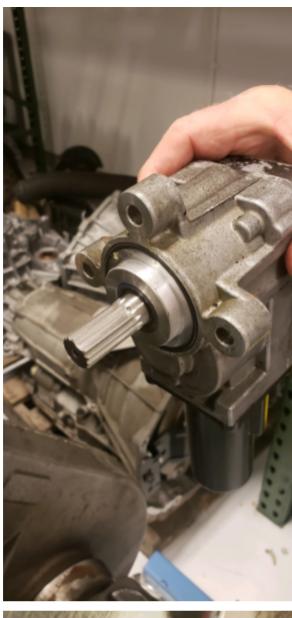
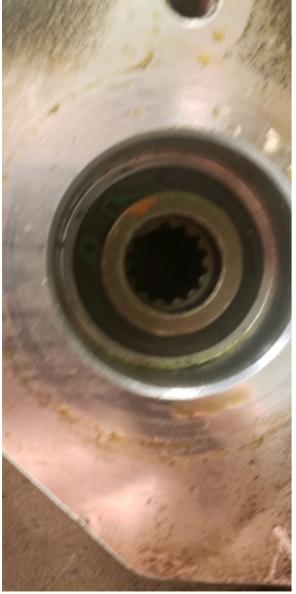
When properly aligned, the keyway spline on the internal shift shaft and the transfer case actuator should be in roughly the 10 O'clock position (See Examples in the pictures below)

If the alignment spline is not in this location, the bolt holes that attach the actuator to the transfer case will not align.

Due to the unique build of this transfer case and the non-synchronized nature of the gears, twisting or moving the actuator to line up the bolt holes will cause the internal gears of the transfer case to bind

This bind can and will prevent the learn from completing when completing repairs to the unit or replacement of the actuator

When installing, the actuator should slide fully into position and there should be no need to move the actuator to align the holes

If the actuator is in the proper position and the transfer case shaft is not, the shift shaft of the transfer case can be moved using a suitable tool to move it to the 10 O'clock position

If the alignment spline on the transfer case is not located in the 10 O'clock position, do not attempt to move the actuator using the scan tool. Instead, using a fused jumper wire on the bi-directional transfer case actuator circuits and a suitable power supply or battery, jump the control circuits of the actuator motor to move the spline into the correct location
