| Dealer Principal | General Manager | Sales Manager | Service Manager | Parts Manager | Marketing | Finance |
|---|---|---|---|---|---|---|
| Bulletin #: A 12 2022 07 | | Name: | | | Supersedes: n/a | |

## Aftersales Bulletin

### 00 17 19 02 00 – Coolant Pipe Jubilee Clip Check and Rework

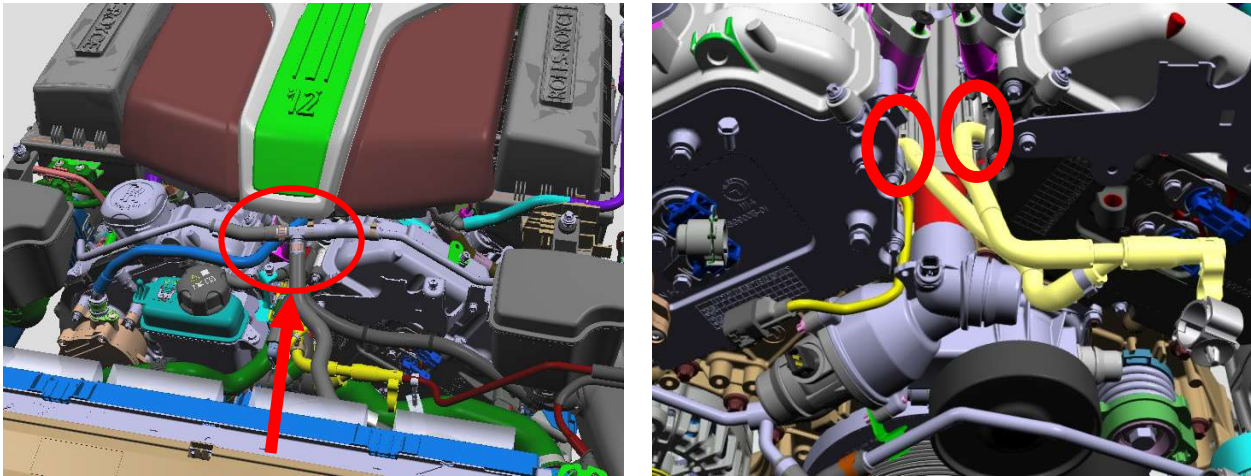
A Rolls-Royce Phantom (RR11/12), Ghost (RR21/22) and Cullinan (RR31) vehicles have been identified as having a potential issue concerning the 2 x coolant pipe connections at the cylinder head. The coolant pipe retaining clips (jubilee clips) may not have been fitted in the correct position, which could result in a coolant leak.

- 1) Locate connection of 2 x coolant hoses at the cylinder head.

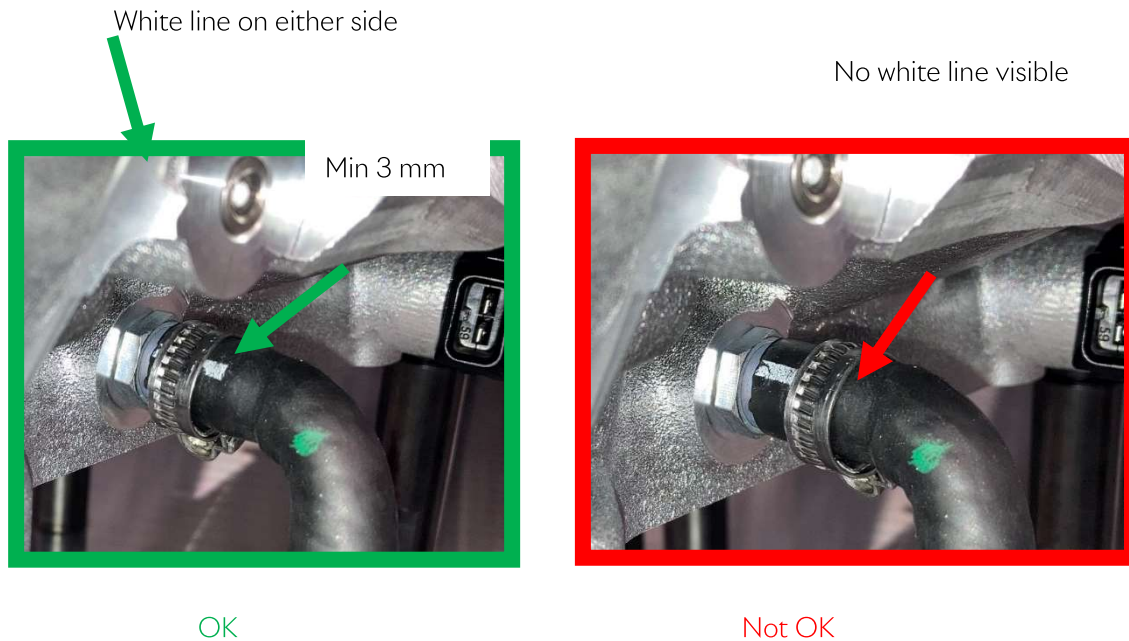
These pictures are for reference only.

- 2) Using an endoscope, check if the retaining clips (jubilee clips) are secured in the correct position. The hose should be fitted closely to the mating part and the retaining clip (jubilee clip) should be positioned with white marks being visible on both sides of the clip.

There should be at least 3mm length of white mark visible on the side away from the cylinder head.

If any or both parts are Not OK, please continue with the following rework to tighten the jubilee clip into the correct position.

- 5) Loosen the jubilee clip, push the hose fully up to the mating surface of the union on the cylinder head.
- 6) Tighten the jubilee clip with 1.5Nm, ensuring that at least 3mm of the white line is visible on the side facing away from the cylinder head (as in the reference picture above).
- 7) Reassemble engine and top up any escaped coolant.
