No Remote key function

REF NO: TJ 35954.14.0	ISSUING DEPARTMENT: Technical Service	CAR MARKET: United States and Canada	
PARTNER: 3 US 7515 Polestar		ISSUE DATE: 2022-11-18	STATUS DATE: 2022-12-06
FUNC GROUP: 3666	FUNC DESC: Access (central looking & remote)	Page 1 of 5

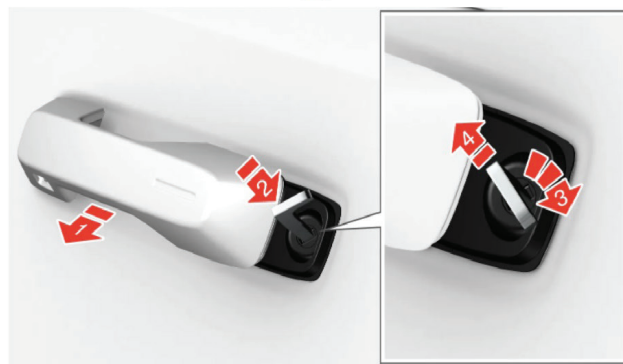
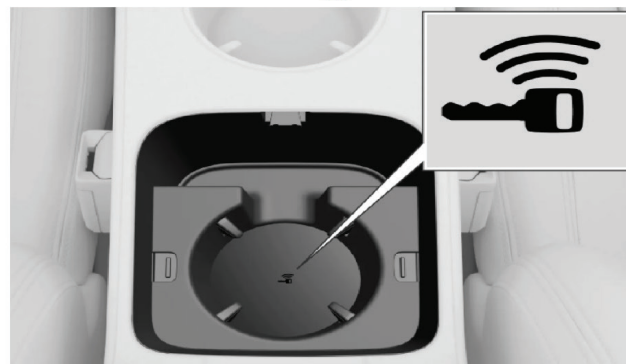
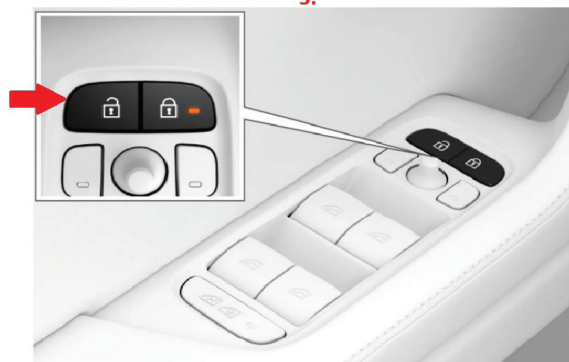
1. Unlock the vehicle with the mechanical key blade inside the "RCK".
2. Place the "RCK" in the backup position.
3. If the vehicle "wakes up", press the 'Release the cable' button in the center display.
