Technical product information

Topic	Water leak/wind noise diagnosis
Market area	Bentley; worldwide (2WBE)
Brand	Bentley
Transaction No.	2062622/2
Level	EH
Status	Approval
Release date

Water leak/wind noise evident

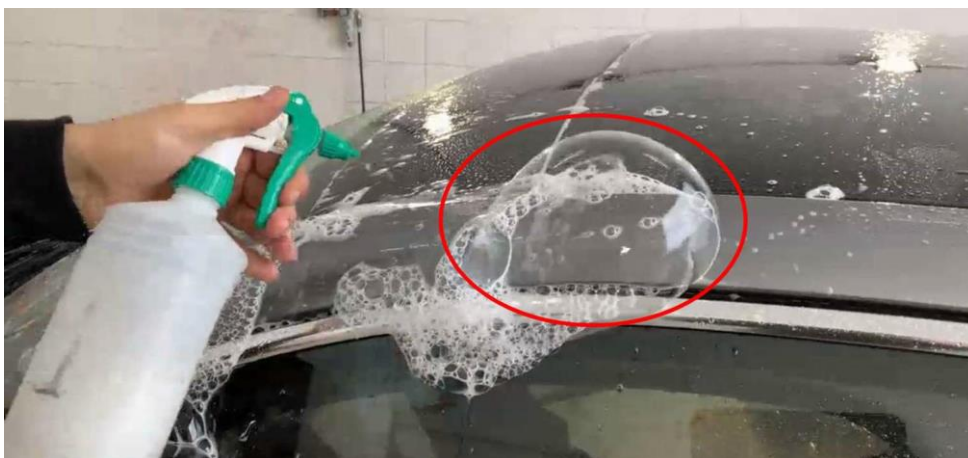
1) Referring to the example shown in Figure 1 - Apply a suitable soapy solution to the exterior of the vehicle in the location which the leak or wind noise is evident

- The operative on the outside of the vehicle should watch for bubbles (Figure 1 CIRCLED), the bubbles will confirm the location of the leak
- 3) Conduct a further inspection to determine the reason for the leak - *For example an incorrectly fitted seal*
