Technical product information

Topic	Engine overheating - Warning on the DIP - V8 Kovomo
Market area	Bentley: worldwide (2WBE)
Brand	Bentley
Transaction No.	2061369/5
Level	EH
Status	Approval
Release date

Bentayga-New Continental GT/C-New Flying Spur (V8 Kovomo)

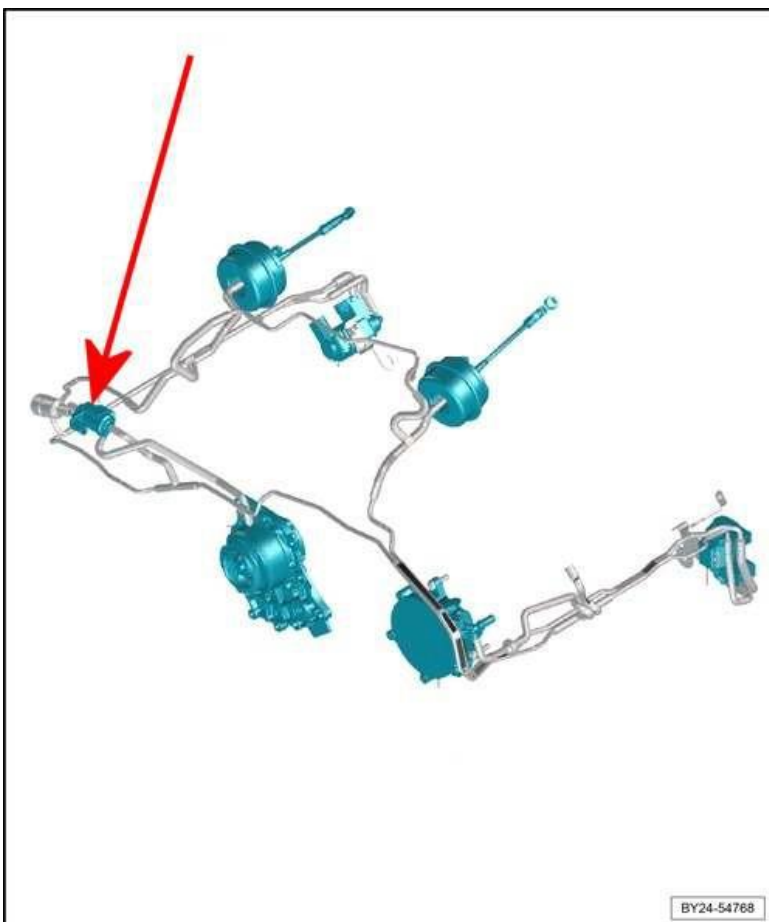
Figure 1 Shows Bentayga (Arrow)

- The switch valve for mechanical coolant pump N649 is designed to cut off the vacuum supply to the coolant pump when the engine reaches maximum temperature, the vacuum cut off allows the engine to start circulating coolant by retracting a sleeve which is situated around the coolant pump impeller

TIP: When the switch valve for mechanical coolant pump N649 is at fault (sticking open) the vacuum supply is constant, this allows the sleeve to stay in position around the impeller which leads to the symptoms described within the Customer statement/Workshop findings section of this TPI

IMPORTANT: The switch valve for mechanical coolant pump N649 fails due to an internal leak from coolant pump causing corrosion within the unit from coolant migration

1) Referring to Figures 1,2 and 3 - With care (visually monitor for any traces of coolant) disconnect each vacuum hose from the switch valve for mechanical coolant pump N649

2) Referring to Rep.Gr 19 - Replace all of the following parts

- Coolant pump
- Coolant regulator (Thermostat)
- Switch valve for mechanical coolant pump N649
