# **Technical product information**

Topic	Coolant leaking from the mechanical coolant pump - Low coolant level warning - Engine overheating - DTC's evident
Market area	Russische Föderation (5RU), Australia E04 Bentley rest Asia and Australia (6E04), China 796 VW Import Comp. Ltd (Vico), Beijing (6796), Germany E02 Bentley rest Europe (6E02), Japan E03 Bentley Japan (6E03), Korea, (South) E08 Bentley South Korea (6E08), United Arab Emirates E06 Bentley Middle East and Africa (6E06), United Kingdom E01 Bentley UK (6E01), United States E05 Bentley USA and rest America (6E05)
Brand	Bentley
Transaction No.	2065919/6
Level	EH
Status	Approval
Release date

## W12 Bentayga - New Continental GT/GTC - New Flying Spur

Transaction No.: 2065919/6

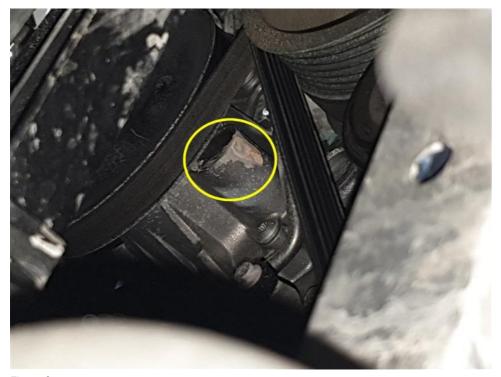
Figure 2

Refer to the video located within the Bentley Hub reference TPI 2065919/- this video shows an example of a coolant pump with no leak although there is a small coolant witness mark evident (Figure 2) in this scenario the coolant witness mark should be cleaned off (using a suitable cleaning agent) to the condition shown in Figure 3

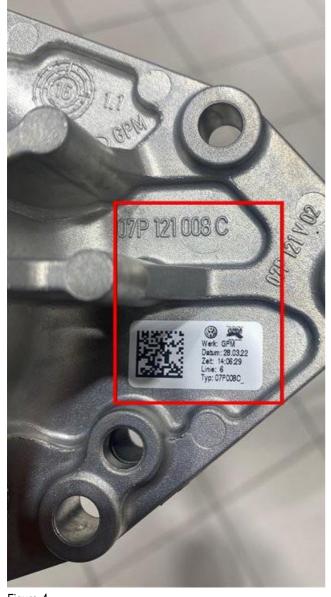
NOTE: The photo shown in Figure 4 is a C level coolant pump (shown removed from the vehicle for photographic purposes) a borescope may have to be used for photos of the coolant pump when fitted

- Once permission has been given via the technical DISS query, replace the following
- Mechanical coolant pump Rep.Gr 19
- Solenoid for coolant circuit N492 assembly Rep.Gr 19
