Technical product information

Topic	Rear seat massage function not working
Market area	Bentley: worldwide (2WBE)
Brand	Bentley
Transaction No.	2068981/1
Level	EH
Status	Approval
Release date

Bentayga Series

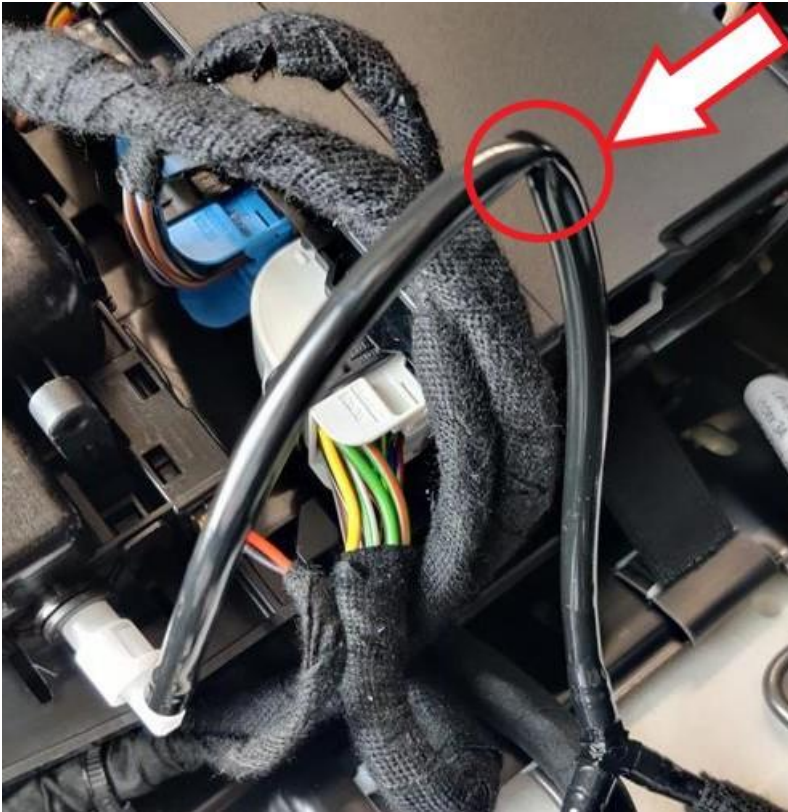
Figure 1

- Pneumatic massage pads
- Air supply lines checking for bends/kinks (Figure 1 shows an example)
- Disconnected air supply lines
- Air leaks
- Referring to the applicable wiring diagram - Conduct a wiring integrity check of the applicable electrical circuits

- In the event an air supply line is found to be bent/kinked the operative should attempt to reposition the air supply line

- If this is not possible (Air supply line is damaged after repositioning) go to Step 5

5) Referring to the applicable Rep.Gr - Replace the applicable component
