## Technical product information

<b>Topic</b>	Front door clash condition with the rear door brightware or clash between the front and rear door brightware
<b>Market area</b>	Russische Föderation (5RU),Australia E04 Bentley rest Asia and Australia (6E04),China 796 VW Import Comp. Ltd (Vico), Beijing (6796),Germany E02 Bentley rest Europe (6E02),Japan E03 Bentley Japan (6E03),Korea, (South) E08 Bentley South Korea (6E08),United Arab Emirates E06 Bentley Middle East and Africa (6E06),United Kingdom E01 Bentley UK (6E01),United States E05 Bentley USA and rest America (6E05)
<b>Brand</b>	Bentley
<b>Transaction No.</b>	2068064/2
<b>Level</b>	EH
<b>Status</b>	Approval
<b>Release date</b>

### Bentayga and Bentayga EWB

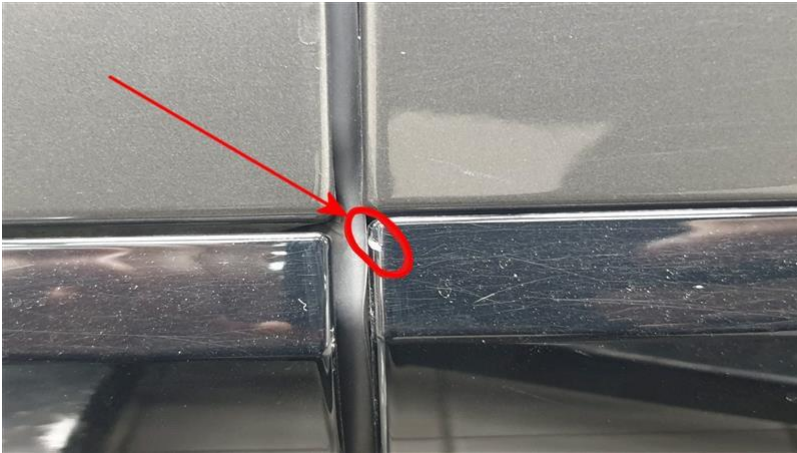
Figure 1

The front door inner panel hem is clashing with the rear door lower brightware (Figure 1) during the closing operation of the front door  
 Or

The clash condition can occur on the left and/or right hand side

1) With extreme care - Use a suitable "smooth cut hand file" to remove the raised inner door panel hem edge, until the hem edge is as shown in Figure 5

2) Once the protruding hem edge has been suitably reduced, close the front door to confirm the issue is resolved (No clash condition evident between the front door inner panel hem and the rear door lower brightware)

3) Conduct a paint repair to the applicable area **ensuring all approved paint repair guidelines are strictly followed to eliminate the risk of any paint and/or corrosion related issues**

4) Referring to Rep.Gr 66 - Replace the rear door lower brightware

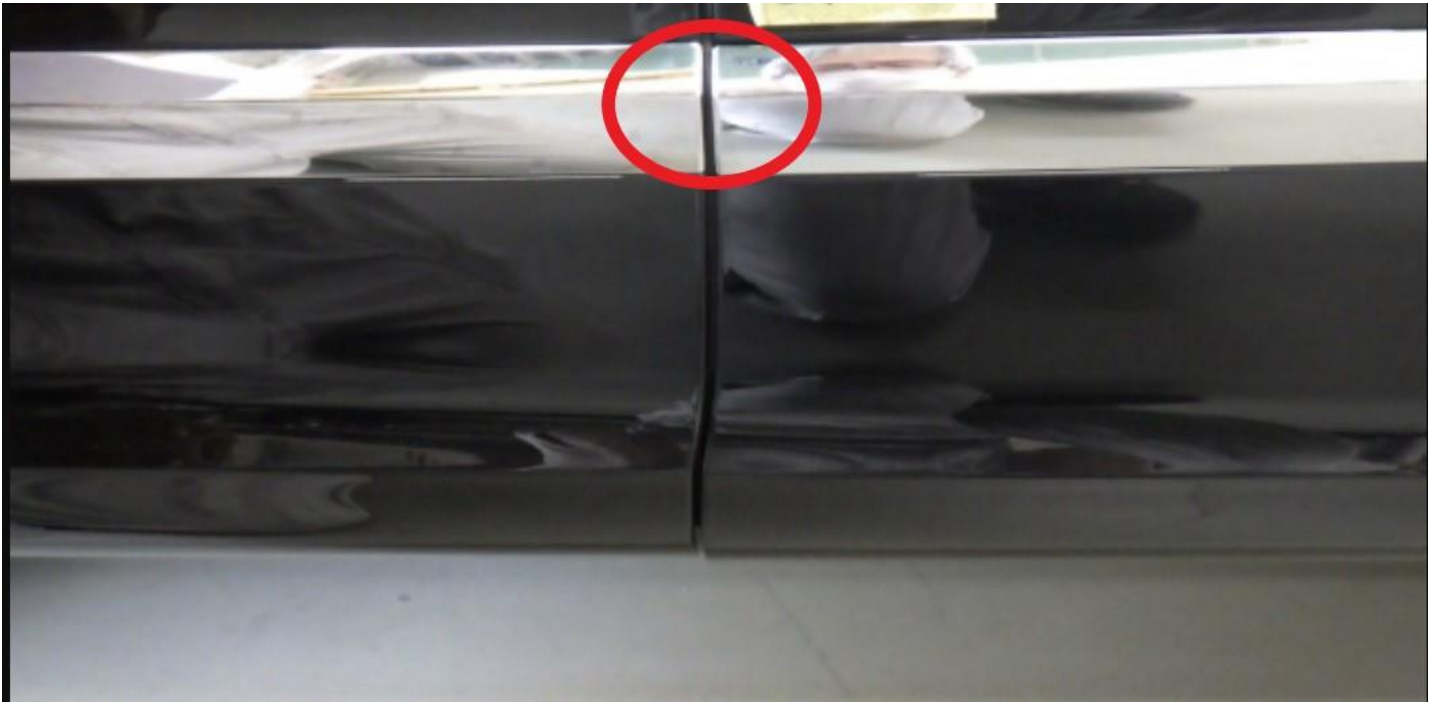
The rear door lower brightware is clashing with the front door brightware (Figure 2)

In the event the rear door lower brightware is clashing with the front door lower brightware as shown in Figure 2 the operative should conduct the instructions within the Measure section for (Scenario 2)

In the event the issue is as described and the clash condition is between the rear door lower brightware and the front door lower brightware the operative must refer to the instructions within Rep.Gr 66 - Door lower brightware – To remove and fit ensuring the following before refitting:

- If you are re-using the old part, replace the adhesive strips with "3M automotive acrylic tape" or similar, locally sourced
- Clean the bonding surface of the door with Cleaning solution 3M VHB before refitting the lower brightware

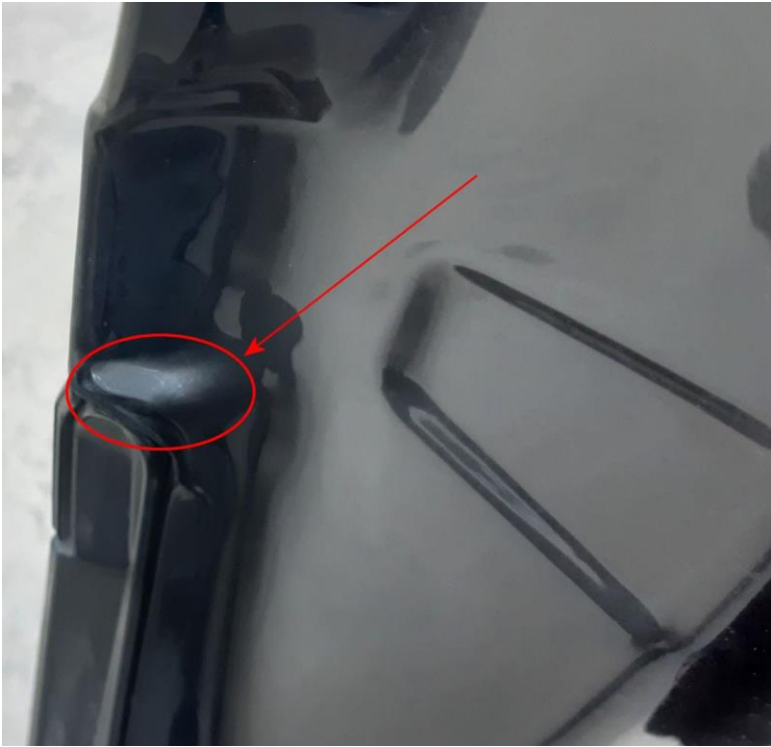
Figure 3

The issue is evident due to a clash condition between the front door inner panel hem (Figure 3) and the rear door lower brightware (Figure 4)
