Technical product information

Topic	New Continental GT / GTC and New Flying Spur - Exhaust Flap - Diagnostic Trouble Code
Market area	Russische Föderation (5RU),Australia E04 Bentley rest Asia and Australia (6E04),China 796 VW Import Comp. Ltd (Vico), Beijing (6796),Germany E02 Bentley rest Europe (6E02),Japan E03 Bentley Japan (6E03),Korea, (South) E08 Bentley South Korea (6E08),United Arab Emirates E06 Bentley Middle East and Africa (6E06),United Kingdom E01 Bentley UK (6E01),United States E05 Bentley USA and rest America (6E05)
Brand	Bentley
Transaction No.	2060432/5
Level	EH
Status	Approval
Release date

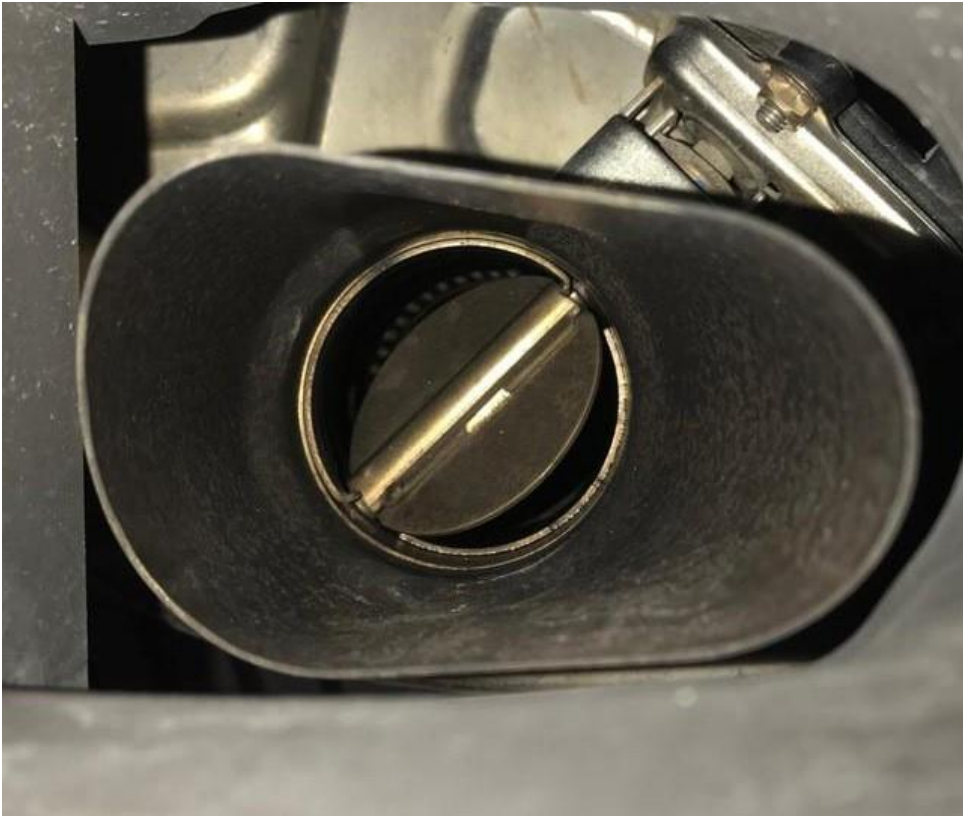
If an Exhaust Flap is stuck in an open, closed, partially closed position or does not achieve a full range of motion continue to follow the instructions within this Technical Product Information (TPI) document - Figure 2

Remove the suspected Exhaust Flap Control Unit – Refer to **Repair Group. 26 Exhaust system – Exhaust flap control units (J883, 945) – To remove and fit**

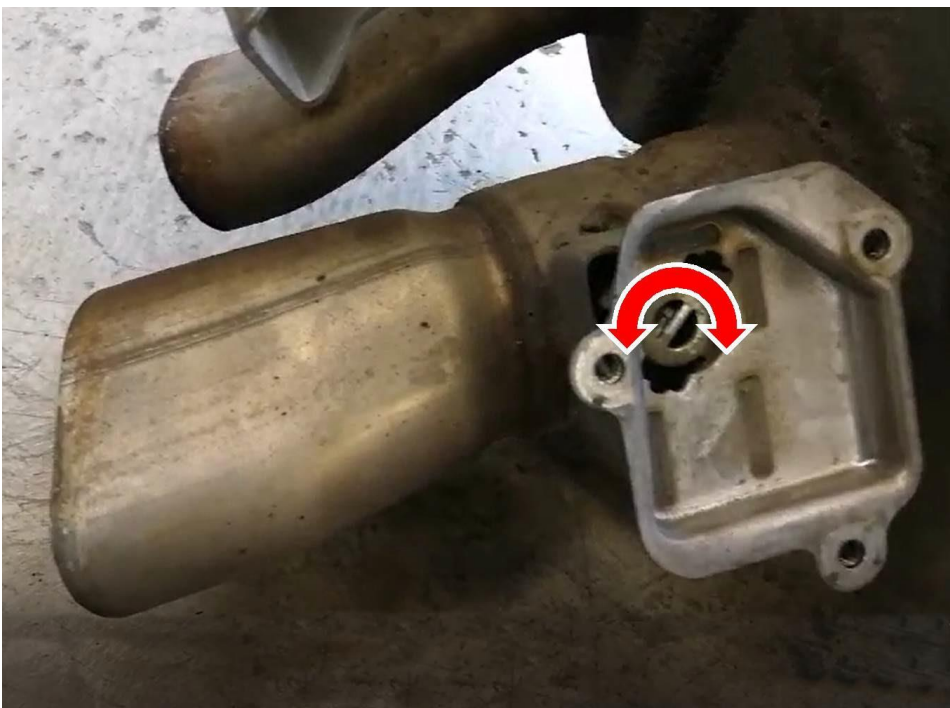
Check and confirm the Exhaust Flap spindle is free to open and close by hand - Figure 3

If no issue is evident and the Exhaust Flap oscillates freely by hand - replace the defective Exhaust Flap Control Unit, refer to **Repair Group. 26 Exhaust system - Exhaust flap control units (J883, 945) - To remove and fit**
