91-23-01TT - RNS 510 Navigation Radio Volume Knob Outer Ring Separated  
- Service Part Available

Release date: 1/26/2023

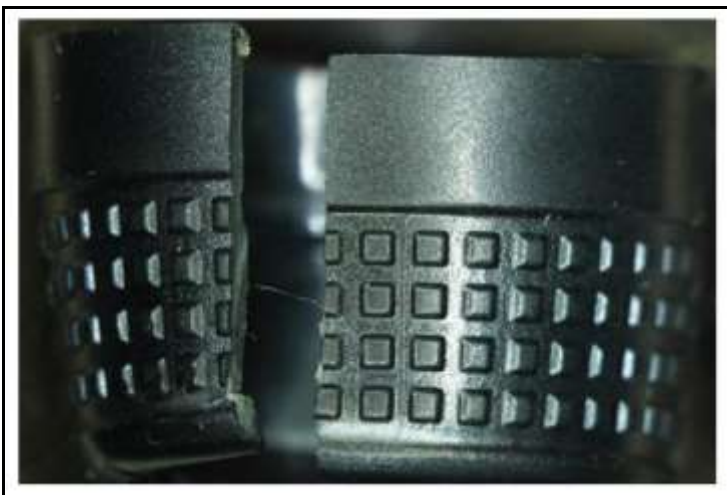
Figure 1.

The customer may complain that the outer plastic ring on the RNS 510 (PR code 7UL) Volume Knob/Power Button has separated and/or has fallen off the knob (Fig. 1).

The RNS 510 Volume Knob/Power Button is now a part that is available separately.

**Part No: 5C0998922** (RNS 510 Volume Knob)
