# Technical Service Bulletin

## 20 Noises from the fuel line

20 23 53 2059997/4 January 31, 2023. Supersedes Technical Service Bulletin Group 20 number 21-37 dated September 30, 2021, for reasons listed below.

Model(s)	Year	VIN Range	Vehicle-Specific Equipment
Q3	2018 – 2024	All	Not Applicable

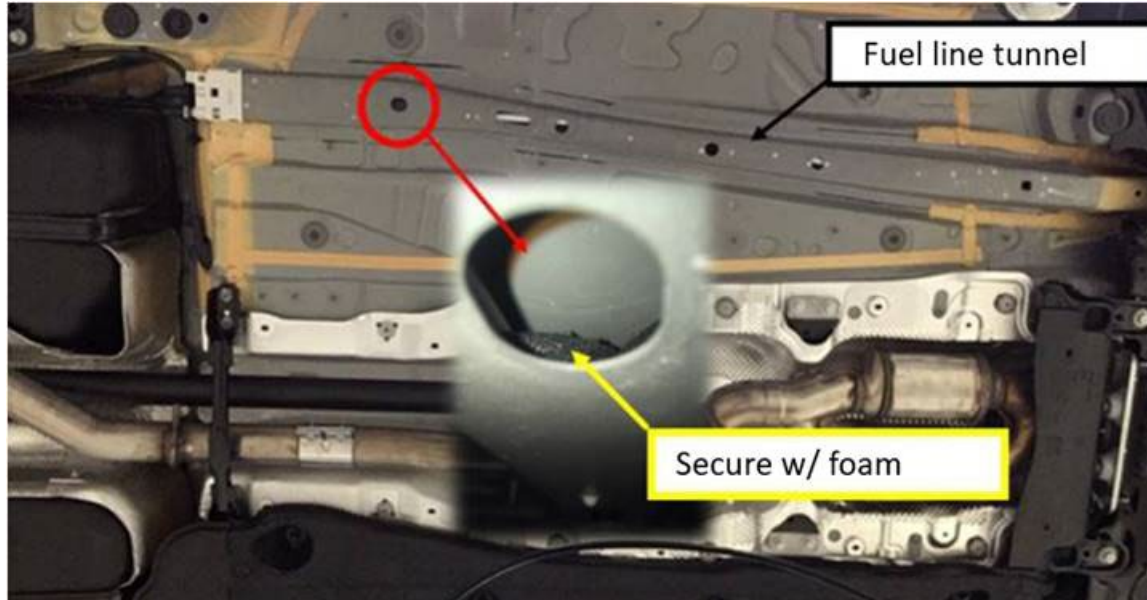
The fuel/EVAP lines in the longitudinal member start to vibrate in certain operating situations and this creates the noise.

Due to pressure pulsation from the high-pressure pump on engine side the underfloor line in the underbody tunnel vibrates. This vibration causes noise that can also be heard in the vehicle interior.

**Figure 1.** Location of the vibrating fuel line.

- Coat the fuel and EVAP line tunnel or fill the space around the fuel and EVAP line with closed-pore foam (foam that doesn't soak up water) part number 321 201 299. This means the fuel/EVAP line does not have to be removed.
