## TECHNICAL SERVICE BULLETIN

### SB-65 2022 & 2023 Allegro Open Road 8K Hollow Leg Jack Replacement

January 3, 2023

# JACK INSPECTION, REMOVAL AND REPLACEMENT (IF NEEDED) FOR 8K JACKS ON MOTORIZED UNITS

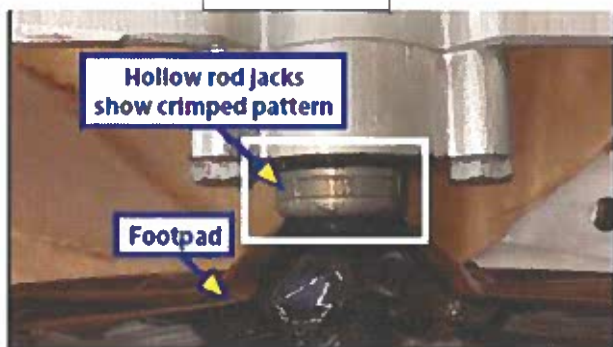
**Figure 1**

Owners may be able to determine if the front jacks installed on their unit are involved and need to be replaced. The pictures below show that the 8k hollow rod jacks that need to be replaced have a crimped pattern directly above the footpad (Figure 1). The 8k solid rod jacks that do not need to be replaced are not crimped directly above the footpad (Figure 2). If the jacks installed on your unit are not involved, you can email that information to [recalls@tiffinmotorhomes.com](mailto:recalls@tiffinmotorhomes.com) along with your VIN number to close the service bulletin for your coach.

Please take your motorhome to a service center of your choice to be inspected and if defective jacks are found they will be replaced with new ones.

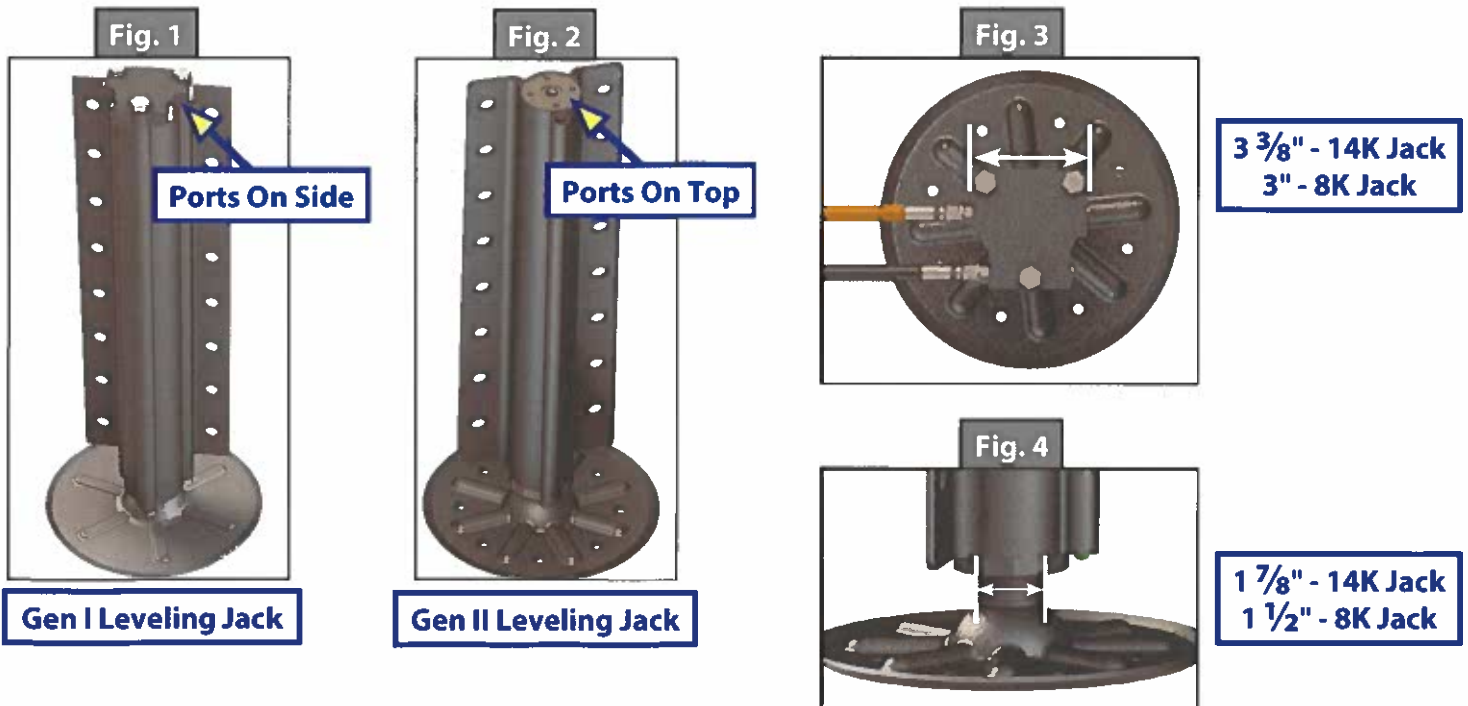
1. Inspect the unit's 8K jacks to determine if they are Gen I or Gen II jacks. Gen I jacks have ports on the side (Fig. 1) and Gen II jacks have ports on the top (Fig. 2).

2. If the unit has 14K jacks, they do not need to be inspected or replaced. The 14K jacks, which are typically located in the rear of the unit, can be identified in two ways:
  - A. By measuring across the top cap of the jack from side to side. A 14K jack should measure  $3 \frac{3}{8}$ " while an 8K measures 3" (Fig. 3).
  - B. By measuring the diameter of the rod that the footpad is attached to. A 14K jack should measure  $1 \frac{7}{8}$ " while an 8K measures  $1 \frac{1}{2}$ " (Fig. 4).

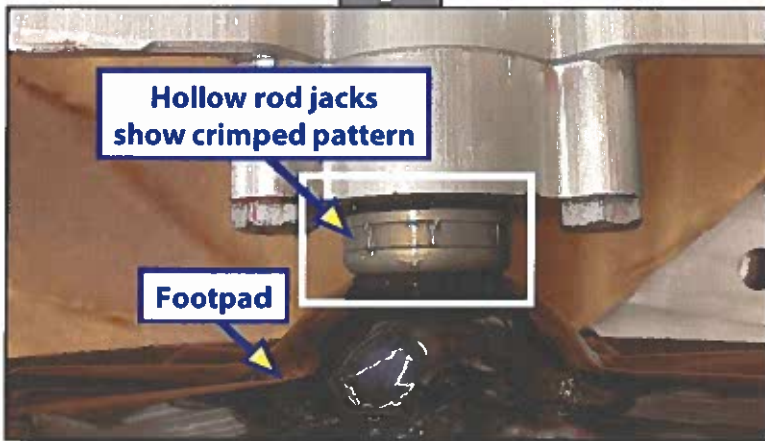
Fig. 5

3. If the unit has 8K Gen I jacks, the ONLY Gen I jacks involved in this TSB document have a crimped pattern which indicates a hollow rod (Fig. 5), visible even when the jack is retracted. Solid rod jacks do not have the crimped pattern (Fig. 6), showing a solid smooth edge around the machined end.

1. Remove hoses from the 8K jacks on the unit.
2. Follow procedures outlined in the Replacement Jack Location section, and then unbolt and remove existing leveling jacks (Fig. 7).
3. Match the number of mounting holes from the first bolt to the bottom of the jack and then bolt the new Gen II jacks (Fig. 8) to the mounting brackets.
  - A. Upper and lowermost bolts are vertically spaced with a minimum of two-hole patterns spaced 4.5" apart (Fig. 9) and tightened. Torque to 90 ft-lbs for a lubricated bolt or torque to 120 ft-lbs for dry bolt. A spacing of three-hole patterns (6.75") is recommended where possible.
4. Measure the distance from the footpad to the ground to verify installation is correct.
5. Connect the hoses to the new 8K Gen II jacks.

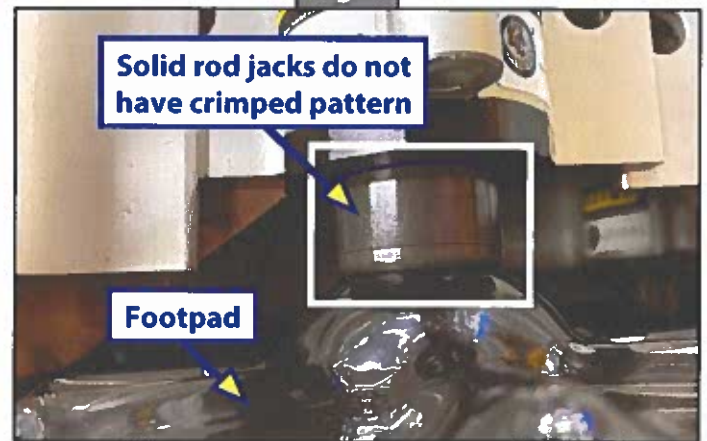
Fig. 6

**NOTE:** If it is determined that the unit has Gen I jacks with a solid rod, then no replacement per this TSB is required.
