# Technical Service Bulletin

## 87 Air conditioning does not cool - P053000, P251500 stored in C5

87 23 38 2068460/2 January 31, 2023. Supersedes Technical Service Bulletin Group 87 number 22-35 dated November 9, 2022, for reasons listed below.

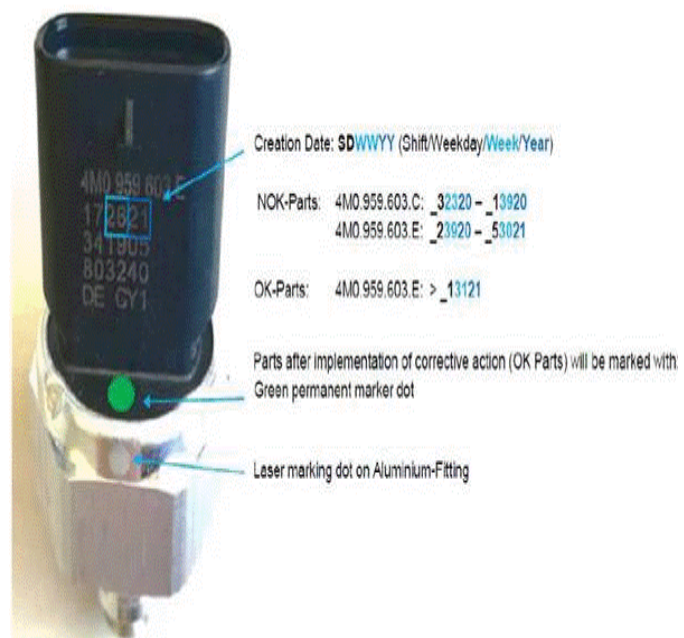
A failure of the sensor electronics causes a loss of pressure evaluation. The sensor with base part number 4M0959603 and a build date *before* the date Calendar Week 31, 2021 is at issue (G395 / G827).

2. Inspect the markings on the sensor to determine if the sensor has been previously replaced with an improved sensor produced after Calendar Week 31, 2021. Figure 1 shows the locations of the markings and their interpretation. In this example, while the sensor is an 'E' index sensor, contains a green dot on the connector housing and a laser marking on the aluminum housing the build date of the sensor is *before* Calendar Week 31, 2021, and would require replacement.

**Figure 1.** Pressure and temperature sensor markings and build date.

1. Should the vehicle present with the symptom profile described in this TSB inspect and/or replace all of the pressure sensors in the refrigerant circuit that are of the base part number 4M0959603 and have a build date before Calendar Week 31, 2021. Each model for which this TSB appears will have between 1 and 3 of this type of sensor installed at various positions in the refrigerant circuit, either on the low or high pressure sides of the circuit (G395 / G827).

3. A sensor with index 'E', produced after Calendar Week 31, 2021, has a green dot on the connector housing, and has a laser marking on the aluminum housing is of the improved type and need not be replaced.
