Staining/Surface Damage on Door Trim Bars and Side Window Trim Element

Topic number	LI72.00-P-075743
Version	1
Function group	72.00 - General
Date	1/4/23
Validity	Model 205.0/2
Reason for change

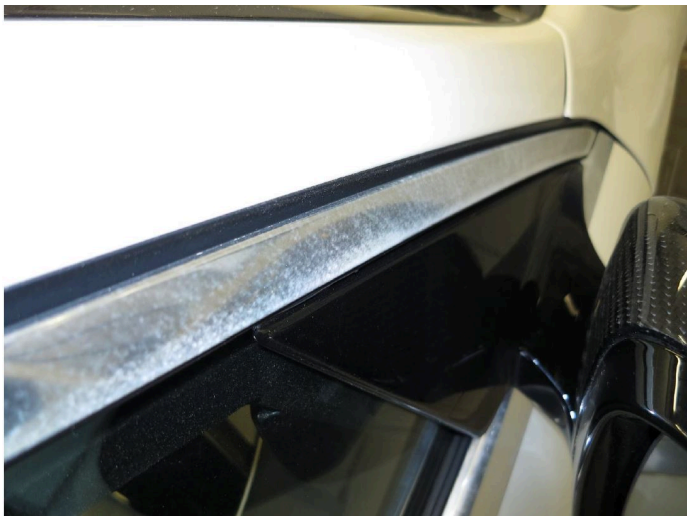
Attachments	
File	Description
Bild 2.jpg

Example of complaint relating to door upper trim strip in silver look
Bild 3.jpg	Example of door trim bar complaint on models with code P59 Black optics

Damage to protective coating of door beltline trim strips, door upper trim strips and side window trim element.

1. Check if the problem cannot be rectified by polishing the trim bars with the polishing paste.
2. If the complaint cannot be rectified, replace the door beltline trim bars, door upper trim bars and rear side window with trim element with optimized protective coating.

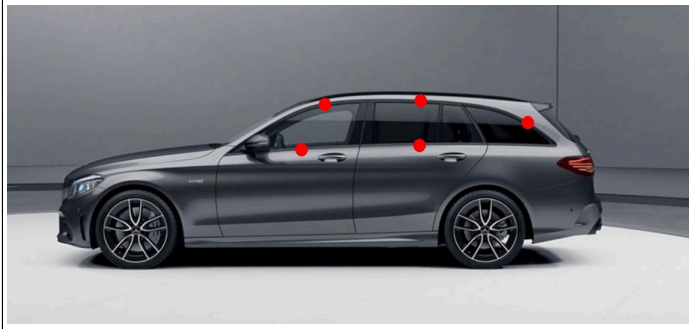
Bild 1.JPG

Staining on door trim strips and top and bottom trim elements on rear side windows. See example pictures 1, 2 and 3.
