INFINITI

TECHNICAL SERVICE BULLETIN

Classification: AN23-002	Reference: ITB23-002	Date: January 18, 2023
-----------------------------	-------------------------	---------------------------

MISSING OR CORRUPTED MAP DATA

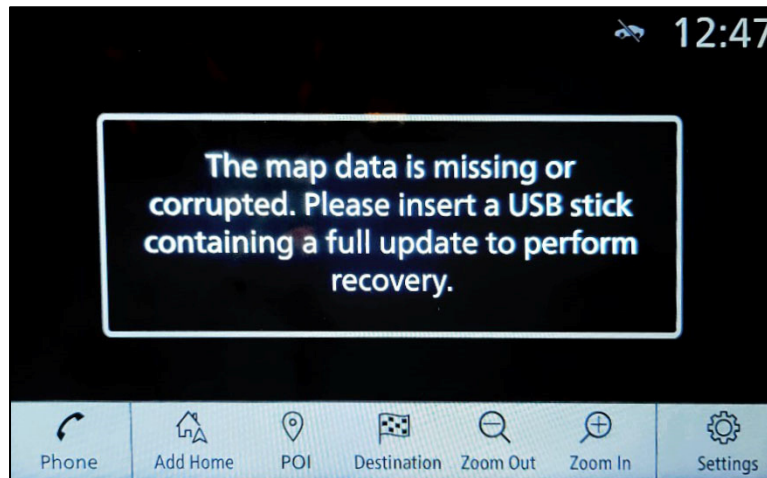
Figure 1

Client states the error screen, shown in Figure 1, appears when using navigation.

Follow the **SERVICE PROCEDURE** in this bulletin to download the map data from the ASIST Downloader, and then update the AV Control Unit with the map data.
