Audi Elsa Newsletter

Edition 94: July 14, 2014

Offboard Diagnostic Information System Service (ODIS Service) & Windows XP – End of Support

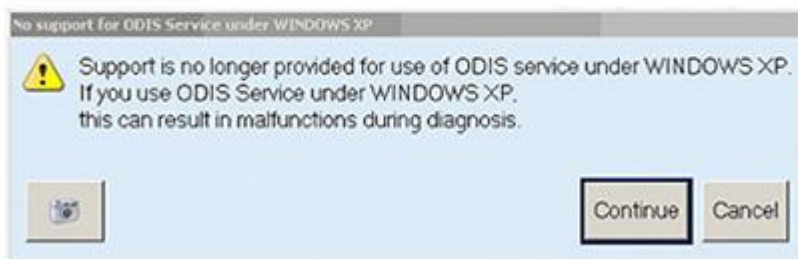
As a result, Audi AG will no longer support ODIS Service functions on devices with Windows XP.

- Beginning with application **version V2.2.0 – feature number 6.0.5**, ODIS Service functions are no longer supported on devices with Windows XP.
- ODIS Service application **version 2.2.0 – feature number 6.0.5** is scheduled for online update release **on July 14th**. The successful installation and function of this update is only possible on VAS diagnostic devices with Windows 7.
- **DO NOT** attempt to install an online update identified by **feature number 6.0.5** (or higher) on devices with Windows XP! The feature number is always indicated in the download prompt.
- If the update specified above is inadvertently installed and ODIS Service is started, the following message will appear:

- To ensure that the latest versions of ODIS Service are always installed, we urge you to update all eligible diagnostic devices from Windows XP to Windows 7 immediately.
