Body/Chassis – Water Leak From Roof Area

22-23MY Range Rover, 23MY Range Rover Sport SVR

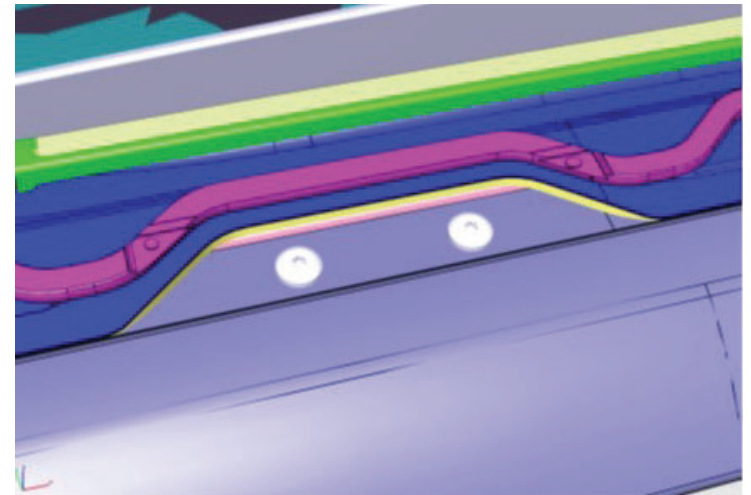
- Water may enter the vehicle cabin through a roof body seam or gap in the panoramic roof opening panel cassette sealant.

- **SSM 75903** has been published to address a potential water leak path through the roof body seam.
- Roof water leaks should be able to be repaired without the need to remove the complete roof cassette assembly.
