Service Bulletin

Bulletin No.: 22-NA-153

Subject: Flutter Noise from Right Rear Corner of the Vehicle

Brand:	Model:	Model Year:		VIN:		Engine:	Transmission:
		from	to	from	to		
Cadillac	Escalade Models	2021	2023				
Chevrolet	Suburban Tahoe						
GMC	Yukon

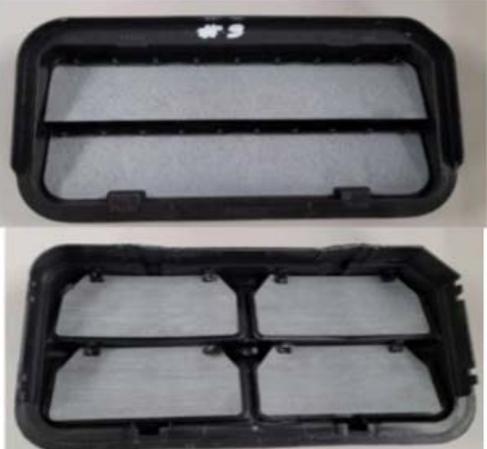
Involved Region or Country	North America, Middle East
Additional Options (RPOs)	
Condition	Some customers may comment on a flutter type noise coming from the right rear corner of the vehicle.
Cause	The cause of the condition may be the Pressure Relief Valve (PRV).
Correction	<div style="text-align: center;">

</div> <p style="text-align: right;">6131341</p> <p>Replace the Pressure Relief Valve with 4 flap design.</p>

If you encounter a vehicle with the above concern, replace the pressure relief valve. Refer to *Body Pressure Relief Valve Replacement* in Si.
