Service Bulletin

Bulletin No.: 22-NA-187

Subject: Information on Service 4WD Light Intermittently Displays On the Drivers Information Center (DIC) and Will Not Engage when Selecting 4WD - DTC C11B9, C05FB, C15C1, C15AB, U0422-71 and/or U0401-71 Set

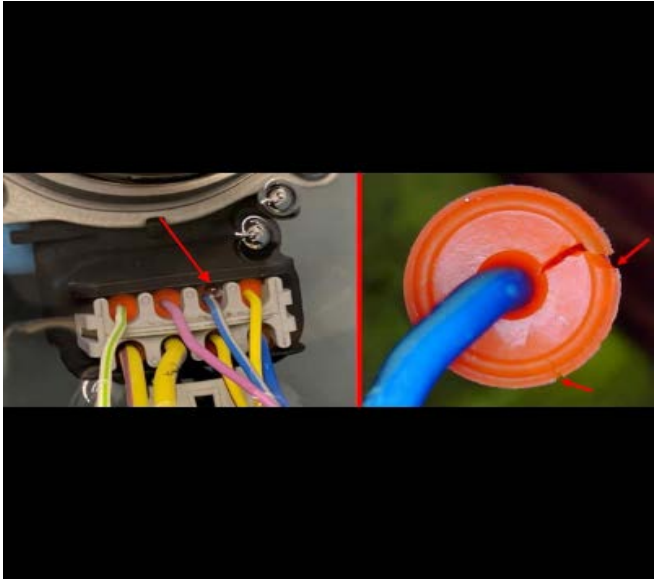
Involved Region or Country	North America
Condition	<p>Some customers may comment that the Service four-wheel drive light will intermittently display on the DIC and will not engage when selecting four-wheel drive.</p> <p>Some technicians may find one or more DTC set:</p> <ul style="list-style-type: none"> • C11B9 • C05FB • C15C1 • C15AB • U0422-71 • U0401-71
Cause	<p>This condition may be caused by potential water intrusion at the Transfer Case Actuator connector on the harness side.</p> <p>– The grommet may be cracked or torn.</p>
Information	<div style="text-align: right; margin-bottom: 5px;">6151017</div>

<p>Inspect the transfer case electrical connector and the transfer case connector on the actuator motor for signs of corrosion. This may indicate that a grommet in said connector may be damaged as shown in the graphic above.</p> <p>– If there are signs of corrosion or damage to the grommet, replace the electrical connector and refer to SI for repair.</p>

Refer to *Wire to Wire Repair in SI* and *Repairing Connector Terminals in SI*.
