Service Bulletin

Bulletin No.: 22-NA-249

Subject: Add-on Accessories Intermittently Lose Power

Brand:	Model:	Model Year:		VIN:		Engine:	Transmission:
		from	to	from	to		
Chevrolet	Tahoe	2021	2023

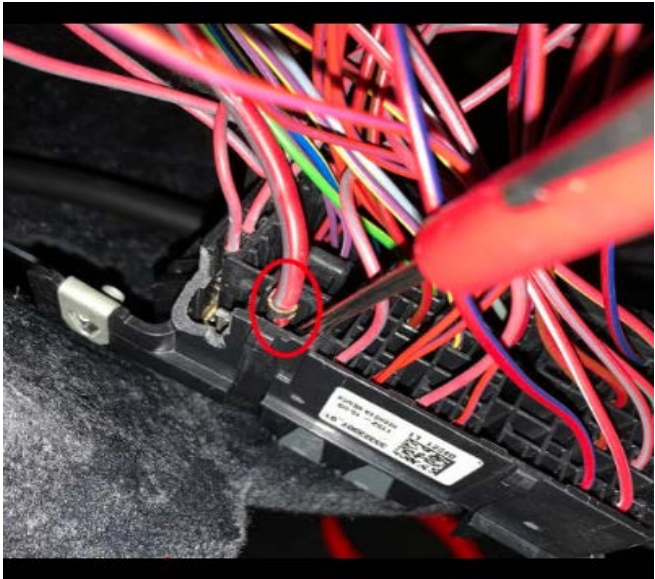
<p style="text-align: right; font-size: small;">6214193</p> <p>This condition may be caused by poor terminal tension at K124 relay in the BUS bar. – Battery power circuit 2742 intermittently opens due to a poor terminal pin grip to the bus bar relay center terminal.</p>
Correction	If the terminal has been found to be loose in the connector, replace the terminal.
