Service Bulletin

Bulletin No.: 21-NA-095

Subject: Malfunction Indicator Lamp (MIL) Illuminated - DTC P1488 or P24DA Set

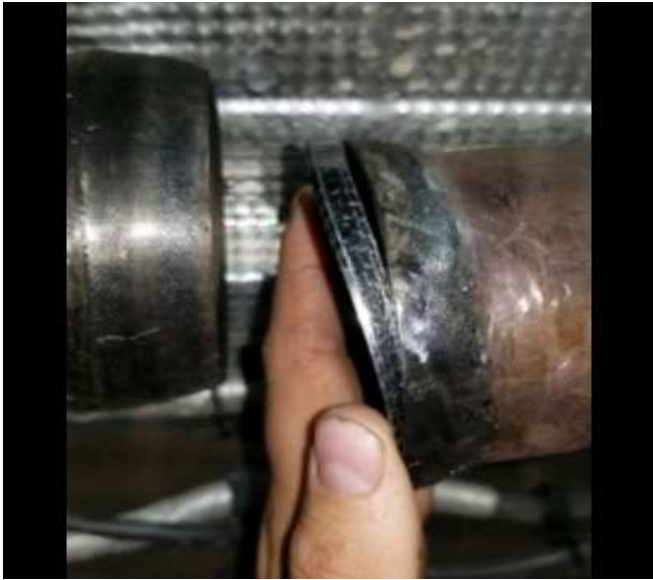
6249341

Note: It is extremely important that the pipes are clean and free of rust.

2. Utilizing an abrasive cloth or equivalent, clean the surfaces of the pipes.
