# TECHNICAL SERVICE BULLETIN

Classification: AN22-031	Reference: NTB23-004	Date: January 13, 2023
-----------------------------	-------------------------	---------------------------

## MISSING OR CORRUPTED MAP DATA

**APPLIED VEHICLES:** 2021-2023 Armada (Y62)  
2021-2023 Maxima (A36)  
2022-2023 Pathfinder (R53)  
2021-2023 Rogue (T33)  
2020-2023 Titan/Titan XD (A61)

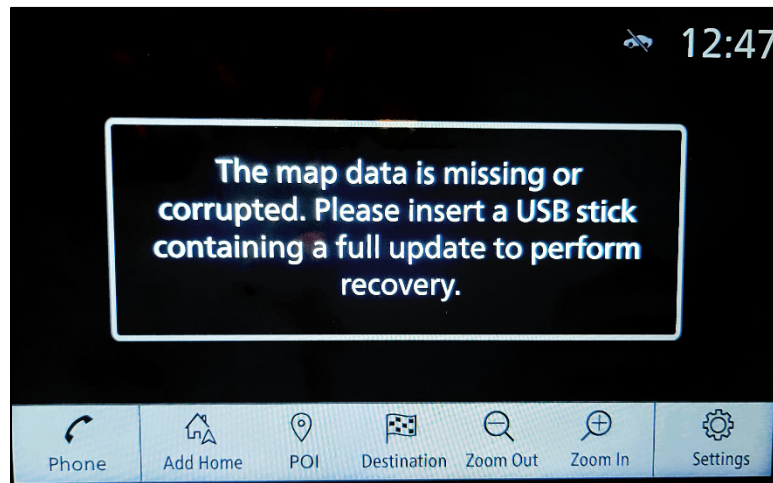
Figure 1

Customer states the error screen, shown in Figure 1, appears when using navigation.

Follow the **SERVICE PROCEDURE** in this bulletin to download the map data from the ASIST Downloader, and then update the AV Control Unit with the map data.
