# Technical Service Bulletin

**01 Engine Crankcase breather Whistling Noise and DTC P227900 warning light ON**  
01 23 43 2069351/1 February 7, 2023.

Model(s)	Year	VIN Range	Vehicle-Specific Equipment
A8	2019 – 2022	All	Not Applicable
S8	2020 – 2022		
RS 6 Avant, RS 7, SQ7, SQ8, and RS Q8	2021 – 2022

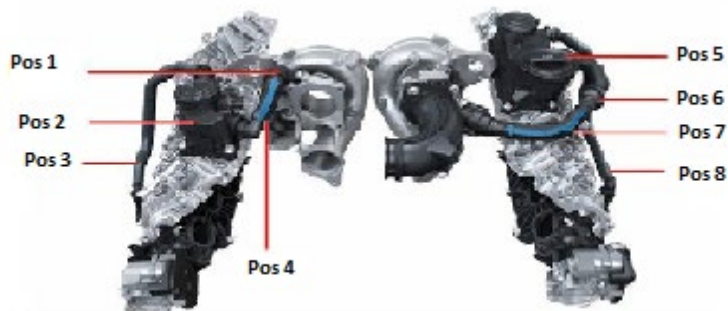
- Exhaust warning light is ON.

- A whistling noise can occasionally be heard from the engine compartment.

- DTC P227900 Intake Air System.
- DTCs connected to misfires may be present on bank 2.

**Item 4: Full load breather line (Replacement required)**

In this case, replace the full load breather line for cylinder bank 1.

- Do not replace the oil separator for bank 1 or bank 2 or the part load breather lines.
- Please refer to image of the crankcase breather from the Self Study Program 920493 as a guide.
