68 Noises from the MMI screen

68 23 41 2061722/5 February 2, 2023. Supersedes Technical Service Bulletin Group 68 number 22-38 dated August 30, 2022, for reasons listed below.

Model(s)	Year	VIN Range	Vehicle-Specific Equipment
Q5, Q5 e quattro, and SQ5	2020 – 2023	All	Not Applicable
Q5 Sportback, and SQ5 Sportback	2021 – 2022

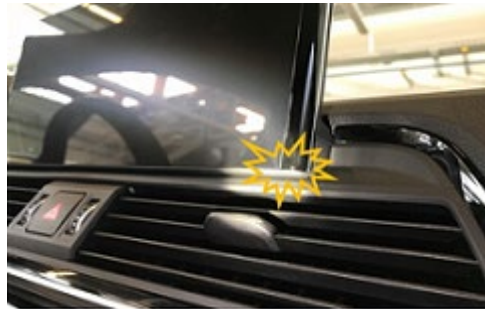
1. Check the gap between the MMI screen and the center vent with a feeler gauge (Figure 1). A gap of 1.0 mm is ideal to avoid any noise-related concerns. If the gap is less than 0.5 mm, perform the following repair.

Figure 1. The gap between the MMI screen and the center vent should be 0.5 mm or greater.

4. Reinstall the MMI screen according to the Elsa repair manual.
5. Recheck the gap between the MMI screen and the center vent to ensure a gap of at least 0.5 mm (Figure 1).
6. Test drive vehicle to verify the repair.

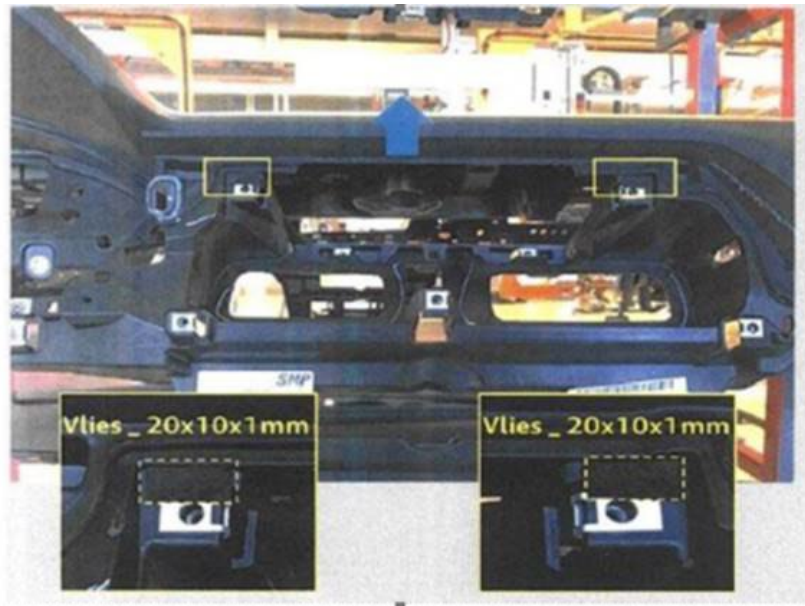
Figure 2. Apply two pieces of felt tape to the dash panel in the area shown.

2. Remove the MMI screen according to the Elsa repair manual.
3. Attach two pieces of felt tape to the MMI screen mounting surfaces in the dash panel (Figure 2).
